SYLWRAP Case Study

Reinforcement of Weakened 22 Degree Elbows

After a blowout in a valve chamber, numerous 22 degree cast iron elbows were discovered to be below specification, requiring urgent reinforcement.

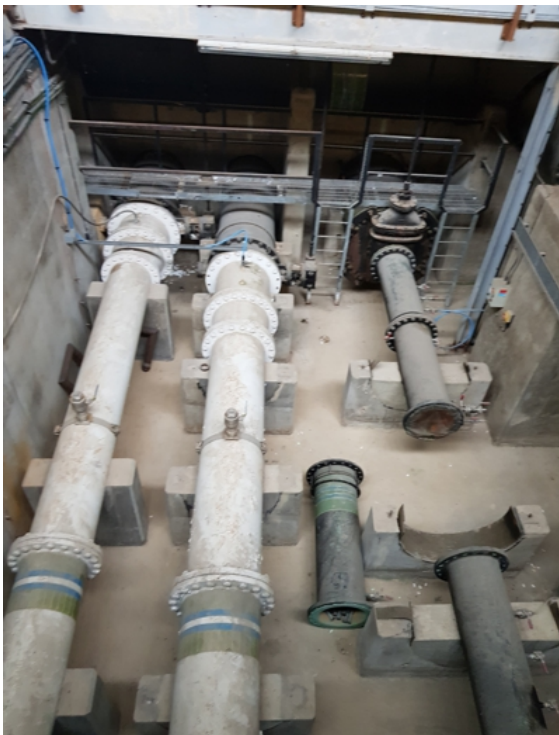
Pipework in the valve chamber

The initial blowout occurred in a 50-year-old 450mm elbow. The water main pump from the reservoir to the treatment works stopped, and the non-return valve closed, causing a pressure surge.

Analysis of the pieces showed no corrosion. The incident was caused by the weakness of the original casting with a hardness of only 107.

To prevent similar future incidents, the water company operating the valve chamber needed to urgently reinforce all remaining elbows.

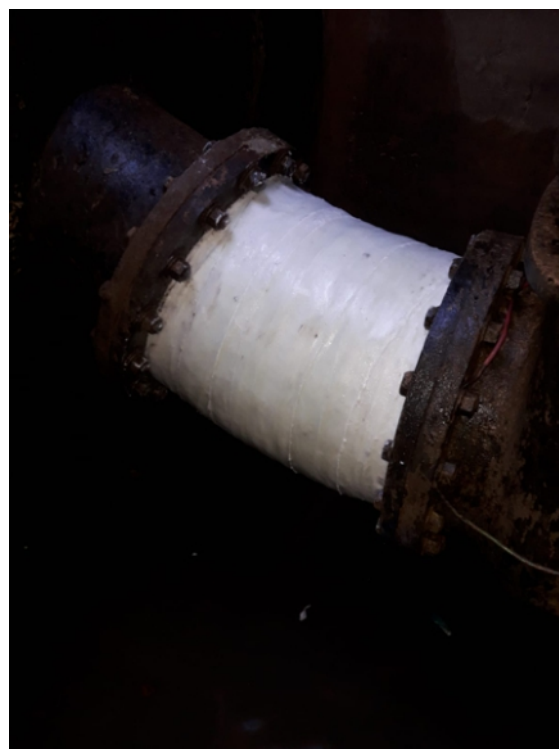
Completed repair showing SylWrap HD wrapped around a 22 degree elbow joint on a 450mm main

The length of the repair area was 350mm between flanges. The application needed to withstand 8 bar operating pressure with fluctuations up to 10 bar.

Each pipe was cleaned and coated with **Liquid Metal Epoxy Coating** to protect against corrosion and provide a PCC-2 compliant load-transfer layer with **SylWrap HD Pipe Repair Bandage**.

10 layers of SylWrap were wrapped over the epoxy, setting rock hard to strengthen the pipework.
