SYLWRAP Case Study

Cracked PCCP Stub Live Leak Repair

After several failed repair attempts, a 250mm cracked PCCP stub with no isolation valve in Saudi Arabia is finally sealed in a complex live leak repair

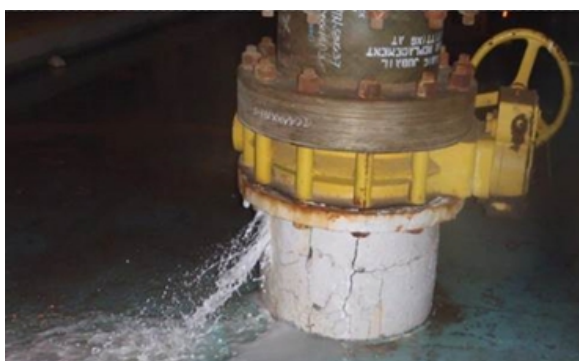
Water escaping from numerous cracks in the stub at 4 bar pressure, causing flooding

The PCCP stub was connected to a main header operating under 4 bar. Wear and tear had caused numerous cracks, through which significant amounts of water was escaping to cause flooding.

With no isolation valve, preventing flow to the stub was impossible. Shutting off the main pipe for either repair or replacement was impractical and there was insufficient room to fit a pipe repair clamp.

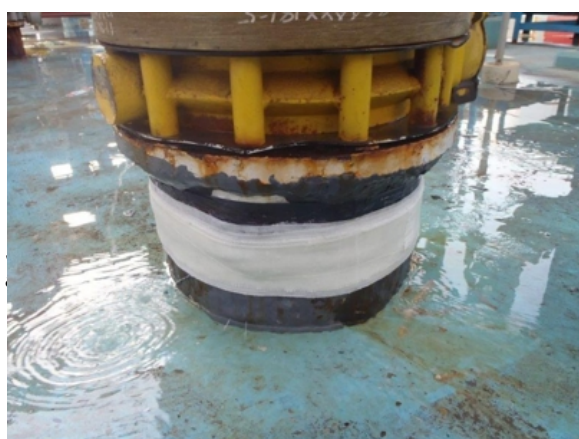
Stub sealed using Wrap & Seal and reinforced with the first layer of SylWrap HD

As this was a live leak, **Wrap & Seal Pipe Burst Tape** was used to seal the cracks. Numerous Tapes were applied down a 200mm section of the stub. These fused to each other to create a repair with pressure resistance to the required 4bar.

SylWrap HD Pipe Repair Bandage was then used to reinforce the Wrap & Seal. Once this section of the stub had been sealed, it was decided to also reinforce the below-ground section to protect against future ruptures in the ageing pipe which would be difficult to identify leaking under the floor.

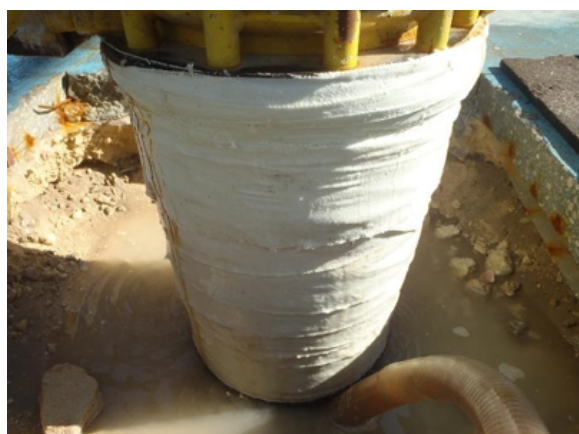
The floor was excavated to access an underground section of the stub with the whole pipe encompassed in a protective sleeve of SylWrap HD

Once the floor was excavated around the stub, a further 200mm section of previously underground pipe was wrapped with SylWrap HD, encompassing the entire stub with a protective sleeve.
