SYLWRAP Case Study

Seawater Cooling Pipe Snapped Nozzle Repair

A petrochemical plant in Saudi Arabia make an urgent repair to a seawater cooling system pipeline after a nozzle snapped off leaving a 50mm hole

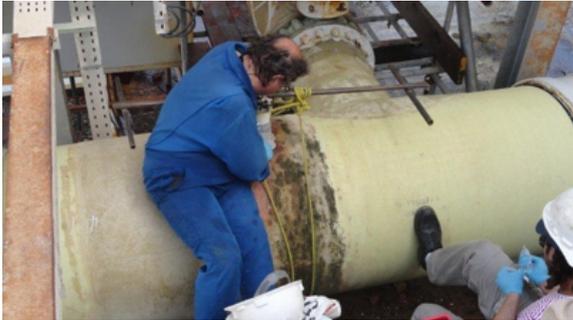
The 1500mm pipe was the main supply line for a cooling system extracting from the Red Sea. When the nozzle snapped off, it left a 50mm hole spraying water five metres into the air at 3 bar pressure.

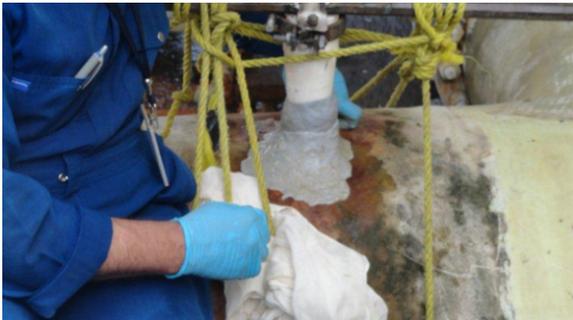
The pipe surface was damaged and weakened by the five metre jet of water spraying out the 50mm hole

Losing so much water impacted the efficiency of the system. It was also causing damage, discolouration and mould to appear where it saturated the line, weakening the exterior pipe surface in the process.
