SYLWRAP Case Study

Restricted Space Malleable Iron Pipe Repair

A repair is made to a 20mm malleable iron water pipe despite space around the leaking section being severely restricted by its close proximity to a wall

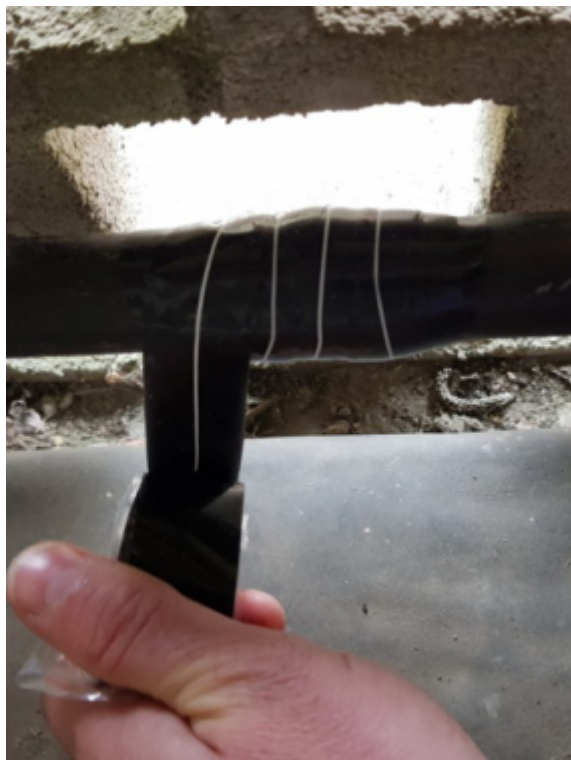
Wrap & Seal was stretched as far as possible by the user into the largest area of space towards them

A small hole had developed where the pipe faced towards a brick wall outside a domestic property. Water was escaping at 3 bar pressure and flow through the leaking section could not be isolated.

Between the pipe and the wall existed only 30mm clearance. There was 150mm between the pipe and the ground. This restricted space made a live repair challenging for the property owner.

Although it could not be stretched by the recommended 300%, **Wrap & Seal Pipe Burst Tape** was still used for the application.

The property owner held the tape tightly to the pipe with their thumb. They then stretched the tape as far as possible towards them before pulling it under the pipe and through the restricted space between the pipe and the back wall.

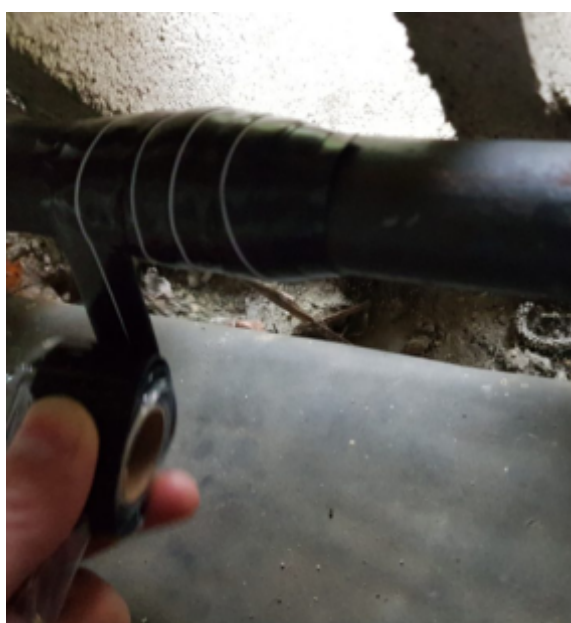
The tape was then pulled under the pipe and up through the 30mm gap between the pipe and the back wall

Once the first wrap anchored the tape in place, the application continued with a 50% overlay. Each wrap followed the stretch, under and up technique.

After the end of the tape was reached, the pipe was dried off. No more water could be felt on the pipe, indicating a successful repair.
