SYLWRAP Case Study

Corroded Porth Pipe Bridge Refurbishment

A dilapidated pipe bridge crossing the Rhonda River in Porth is repaired and refurbished, saving Dwr Cymru Welsh Water from an expensive replacement

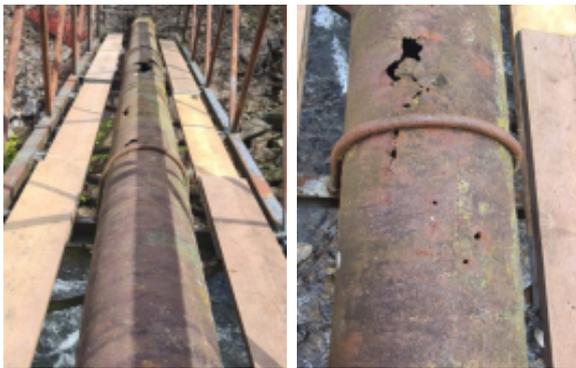
Corrosion had breached the pipe in several places

Dwr Cymru contacted Sylmasta for repair advice and appointed Arch Services as contractors. An inspection by Arch revealed the pipe to be covered in corrosion, leaving large holes in several places.

The holes were too big and the pipe too brittle to be repaired with putty, so Arch layered large fibreglass patches over the cracked sections to seal the leaks.

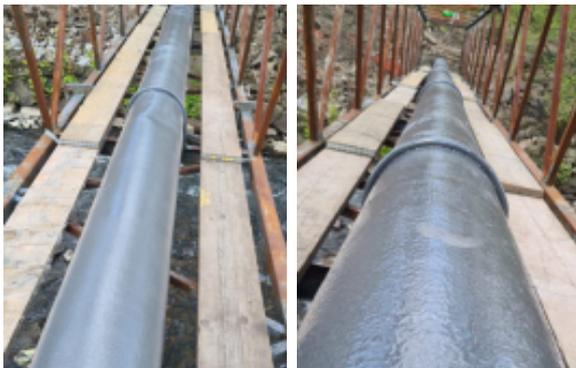
Liquid Metal was painted onto the pipe, curing to form a new, impermeable metallic outer surface

Several layers of **Liquid Metal Epoxy Coating** were then painted onto the pipe and the steel hoops and beams holding it in place, using a roller.

Once cured, Liquid Metal formed a hard-wearing, smooth, metallic, impermeable skin around the pipe. This new outer surface would prevent further corrosion and ensure fluids could no longer escape.

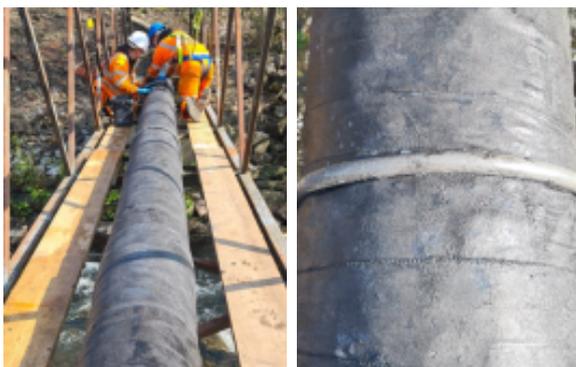
SylWrap CR was carefully applied to the whole line, providing further reinforcement and protection

To further reinforce the pipe and reinstate integral strength, the line was wrapped with four layers of **SylWrap CR Corrosion Protection Wrap**, which formed an impact-resistant protective shell.

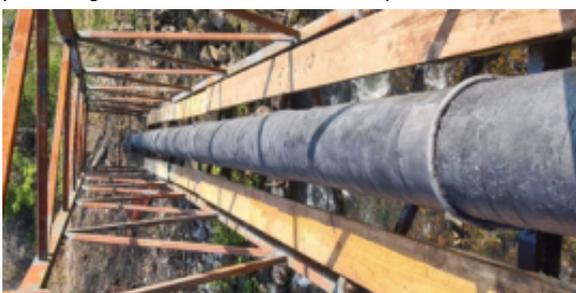
The repair took three days to complete. It left a smart-looking, refurbished pipe bridge fully protected from future corrosion and breaches.

The finished repair left the pipe fully refurbished
