SYLWRAP Case Study

Corroded Steel Gas Pipe Refurbishment

An industrial plant refurbish and repair a three metre section of corroded steel pipe hung from a ceiling and carrying natural gas as part of a CHP system

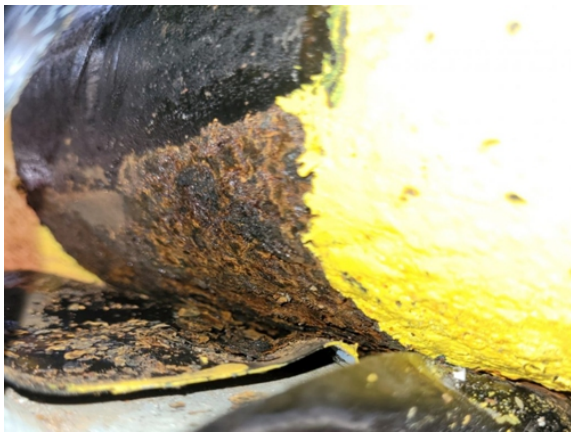
The pipe was heavily corroded where water had been trapped between a protective PVC tape and the line

When installed, the pipe had been wrapped with a protective PVC tape. Incorrect application had left a three metre section where water could become trapped between the tape and the line.

This had caused heavy corrosion, particularly weakening the pipe area resting on the U-support.
