SYLWRAP Case Study

Leaking Welded Saddle Joint Repair

A 150mm steel pipe connected to a pumping house leaking from both ends of a welded saddle joint is sealed in a repair built up and over a 20mm step

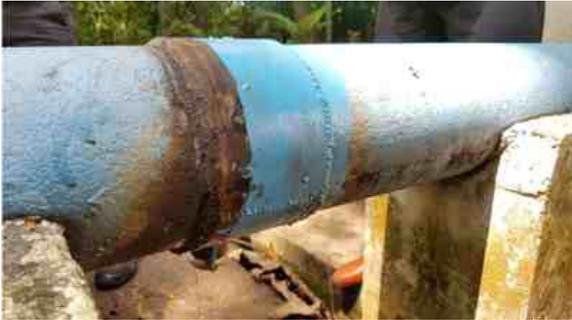
Water was seeping from both ends of the saddle joint, one of which was suffering from heavy corrosion

The saddle joint had been welded in place to reinforce a capped tee on the 150mm steel pipe. The joint sat 20mm higher than the original line.

Water had been found seeping out of the joint. The pipe could not be isolated or replaced as this would involve shutting down the pumping house.

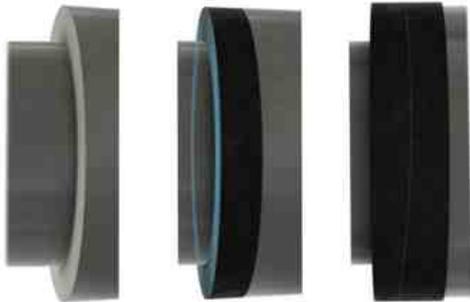
Wrap & Seal application began next to the saddle, was built up until level with the step and then continued across onto the joint

Wrap & Seal was first applied directly next to the step. Each rotation added another layer until the step was bridged, after which wrapping continued 50mm across the saddle.

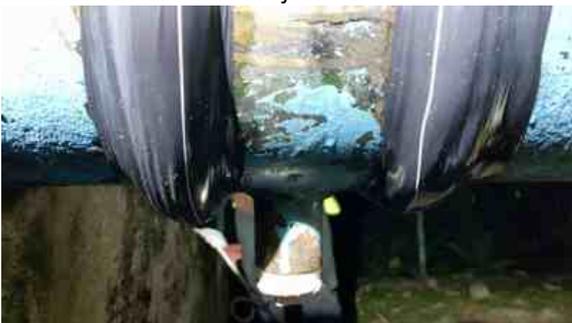
Once the joint ends had been encapsulated, Wrap & Seal was applied directly over the leak to create a ridge increasing the pressure resistance of the repair

Wrapping then returned to the edge of the joint, where a ridge was created over the leak area to increase the pressure resistance of the repair.

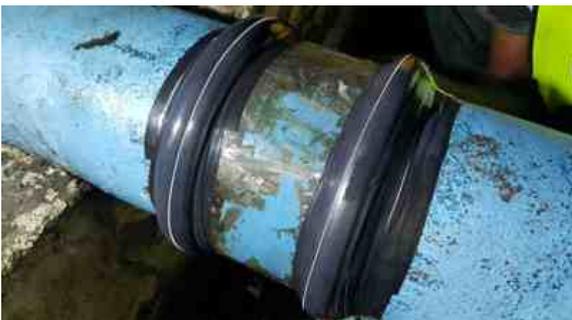
When the pipe surface was found to be dry, the application was deemed a success.

Wrap & Seal was applied to both ends of the saddle joint, successfully sealing the pipe
