# SYLWRAP Case Study

## Heavily Corroded Steel Pipe Reinforcement

An industrial site in Saudi Arabia rebuild and reinforce 2 metres of steel pipe before heavy external surface corrosion could eat through and breach the line

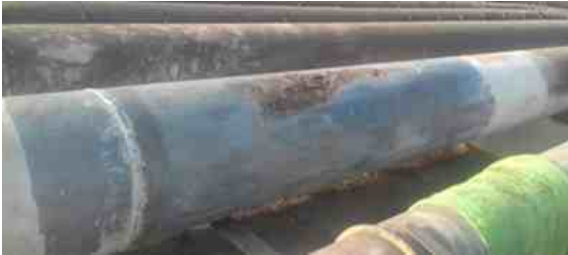
*The 2 metre long section of steel pipe needed to be rebuilt where a 600mm patch of corrosion had severely weakened the line*

The pipe was suffering from a 600mm patch of heavy corrosion to its external surface. It was only a matter of time until this corrosion ate through the remaining brittle steel to breach the line.

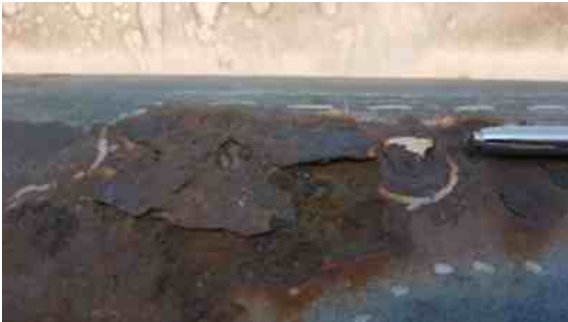
*Closer inspection of the corroded area showed how much external surface damage the pipe had suffered*

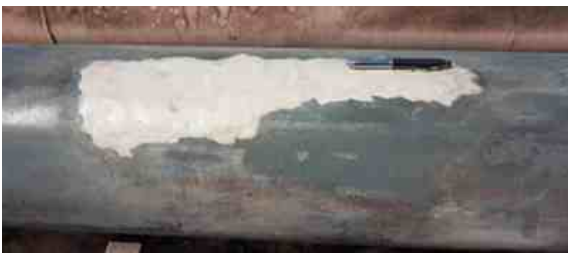
*AB Original Epoxy Putty rebuilt the patch of steel pipe weakened by corrosion to its original thickness. It would offer excellent protection from further corrosion and chemical attack, and act as a sacrificial layer where necessary.*

**Sylmasta AB Original Epoxy Putty** was used to rebuild the corroded area. AB Original offers excellent protection against corrosion and chemical attack.

The Putty was applied over the entire 600mm patch, filling all imperfections, returning the pipe to its original thickness and restoring its integrity.

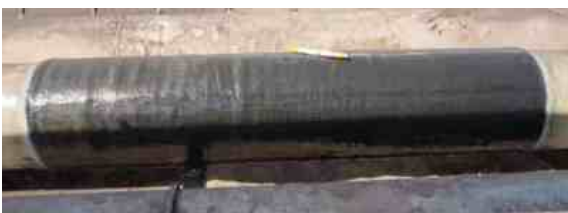
*SylWrap CR was applied to a 2 metre section of the line, centred around the corroded area rebuilt using AB Original. The corrosion inhibitors in SylWrap CR provided greater protection in such an aggressive environment.*

**SylWrap CR** was then wrapped over a 2 metre section of the pipe, including the putty. SylWrap CR contains corrosion inhibitors for further protection of pipework in harsh and aggressive environments.

Within minutes of being activated with water and applied, SylWrap CR had cured to form a rock-hard sleeve around the pipe, further reinforcing the line and protecting it from future corrosion.
