# SYLWRAP Case Study

## Portable Horse Shower Burst Pipe Repair

Sylmasta and Showerking team up to provide a repair method for portable horse shower units with burst copper pipes caused by freezing temperatures

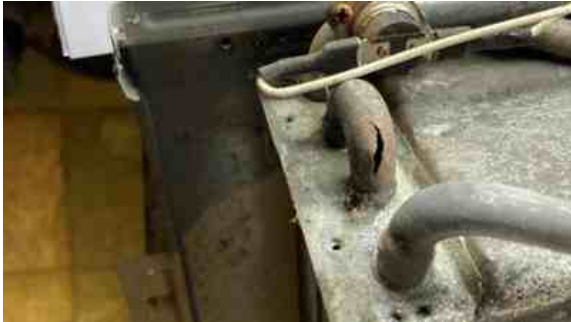
Freezing temperatures caused copper pipework in horse shower units which had not been fully drained to suffer from cracks and bursts

Showerking units are kept in unheated outbuildings. When not fully drained, copper pipe in the system can become prone to bursting during exceptionally cold weather.

When UK temperatures went as low as  $-15^{\circ}\text{C}$ , several horse shower owners reported burst pipes, rendering their units unusable.

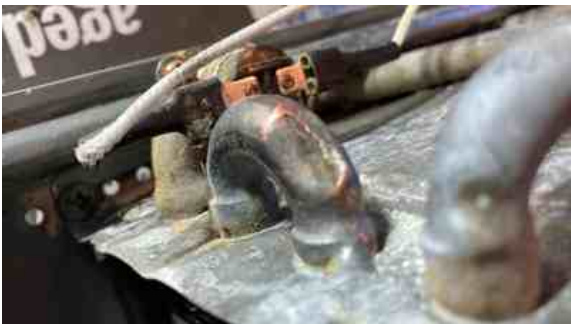
The pipe was cleaned of loose material before repair to aid adhesion with the Epoxy Putty.

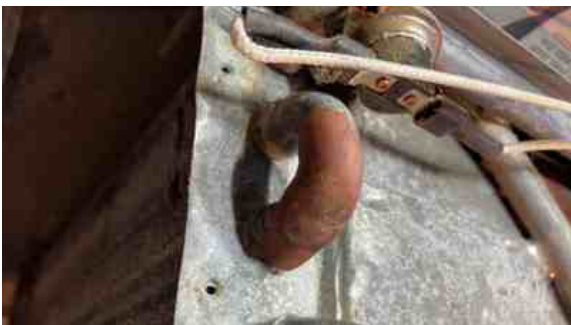
Superfast Copper Epoxy Putty was kneaded by hand and used to cover the crack

Loose material was first cleaned from the pipework. **Superfast Copper Epoxy Putty** was then kneaded by hand and applied, covering the crack.

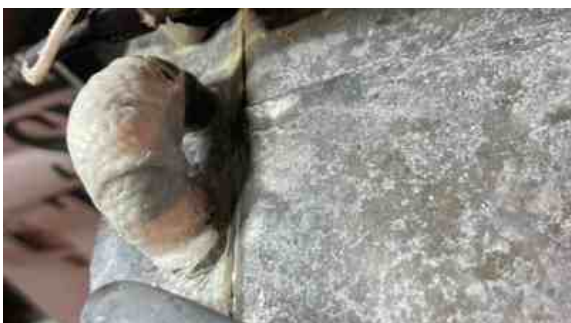
SylWrap Bandage forced the putty into the crack, creating a watertight seal and offering protection from future expansion of the pipe

Before the putty had fully hardened, a **SylWrap Pipe Repair Bandage** was wrapped over the entire leak area, forcing the putty into the crack for a permanent watertight seal.

Within five minutes, SylWrap cured to provide a rock hard shell which reinforced the repair and offered protection from future expansion.
