SYLWRAP Case Study

Pipe Flange Sealed Against Tree Root Ingress

After a tree penetrated a flange on an underground 1800mm steel pipe, a wastewater treatment plant seal the line to prevent future root ingress

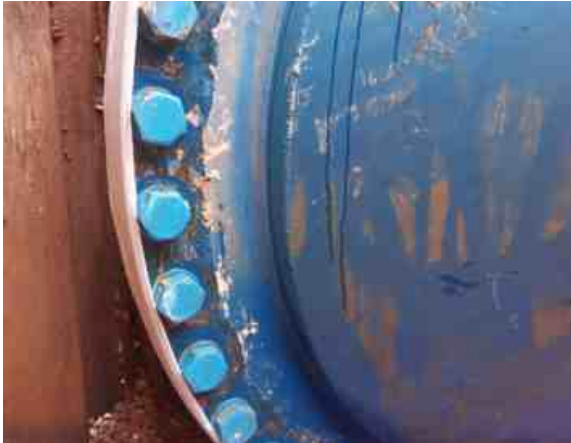
The flange connected a steel pipe to a chlorine tank

The pipe brought wastewater to a chlorine contact tank. After a reduction in performance was noticed, the pipe was excavated to identify the problem.

A tree root had penetrated between two flange plates. The pipe was seeping and partly blocked, causing possible recontamination of water which had undergone most of the treatment process.

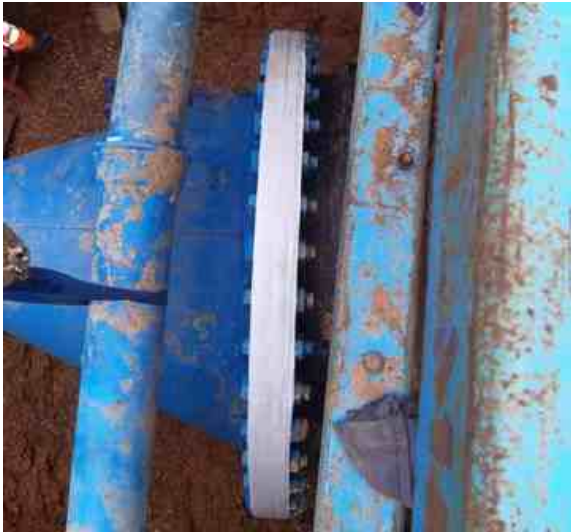
Wrap & Seal was applied all around the flange to seal the leak. It was then overwrapped with SylWrap Pipe Repair Bandage

Wrap & Seal Pipe Burst Tape was wrapped over the point where the flange plates connected. Several Tapes were applied over each other, bonding together to build pressure resistance.

Once no more water was seeping from the flange, **SylWrap Pipe Repair Bandage** was applied over the top. A SYL412HD Bandage was used as its 100mm width fitted perfectly over the flange.

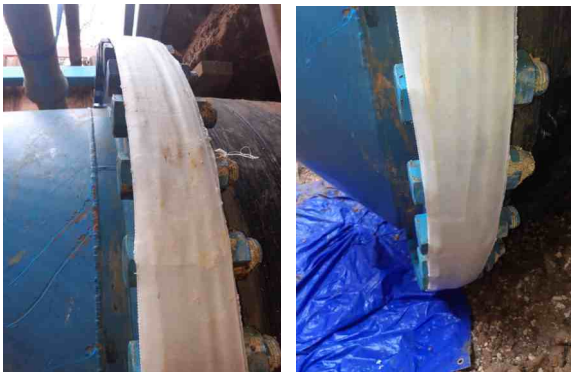
A SYL412HD Bandage was the perfect 100mm width to wrap around the flange, curing to form a rock-hard shell which tree roots would not be able to penetrate in future

SylWrap Bandage cured to form a rock-hard shell around the flange. This reinforced the initial leak repair and ensured the line could not be penetrated through the weak spot between flange plates again.
