Epoxy Putty Case Study

Seawater Cooling System GRP Return Pipe Repair

A leaking 3 metre diameter GRP return pipe in a seawater cooling system is repaired in just two days, keeping downtime at an oil refinery to a minimum

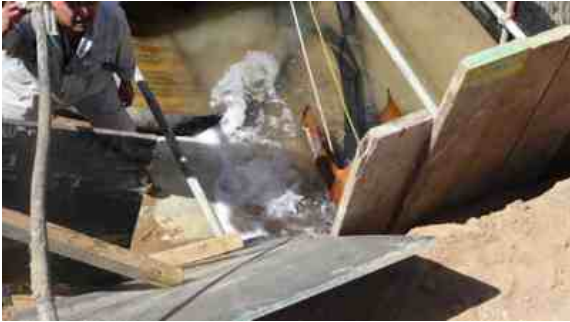
The line was isolated, excavated and re-pressurised. So much water escaped that the hole dug to access the pipe became instantly flooded

When the ground above a return pipe was noticed to be wet, the line was isolated and excavated. Once accessed, the line was re-pressurised. So much water escaped from several areas that the hole dug to reach the pipe was instantly flooded.

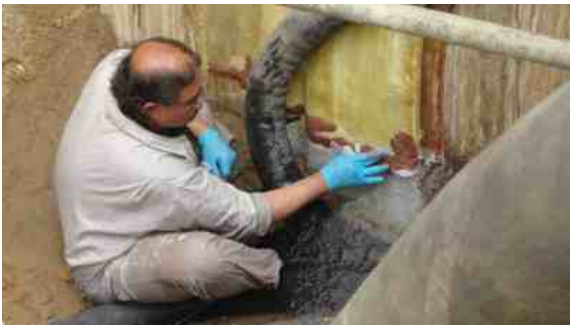
Superfast Copper sealed smaller holes in the line in five minutes

Needing a rapid repair, two epoxy putties were used to seal the pipe. **Superfast Copper Epoxy Putty Stick** was pushed into the smaller holes.

The five-minute work time of Superfast Copper was accelerated by the climate. A putty with a longer work life was required for the bigger holes.

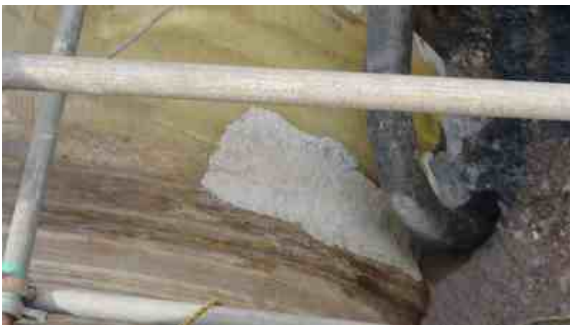
AB Original was used for larger leak areas because its longer work time allowed more putty to be mixed without the threat of premature curing

With a two-hour work time, **Sylmasta AB Original Epoxy Putty** enabled more putty to be mixed and applied without the threat of premature curing.

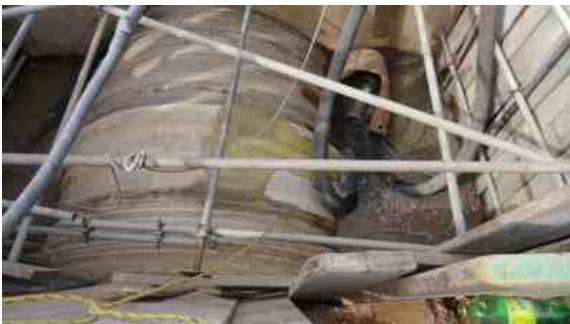
The line successfully sealed prior to being re-buried

Both putties achieved full properties after 24 hours. The line was then turned back on. No water was escaping, meaning the repair was a success and the pipe could be re-buried.
