SYLWRAP Case Study

Corroded Porth Pipe Bridge Refurbishment

Dwr Cymru Welsh Water use the Sylmasta Pipe Refurbishment System to save nearly £200,000 by repairing rather than replacing a dilapidated pipe bridge

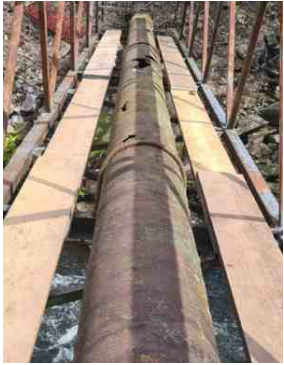
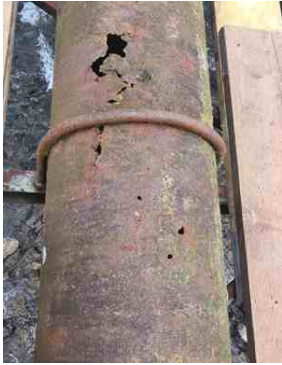
Corrosion had breached the pipe in several places

The gravity-fed bridge crossing the Rhonda River in Porth was made up of a 300mm, 20-metre long steel pipe rested inside an angle-iron structure.

Dwr Cymru contacted Sylmasta for repair advice and appointed *Arch Services* as contractors. An inspection by *Arch* revealed the pipe to be covered in corrosion, leaving large holes in several places.

The holes were too big and the pipe too brittle to be repaired with putty, so *Arch* layered large fibreglass patches over the cracked sections to seal the leaks.

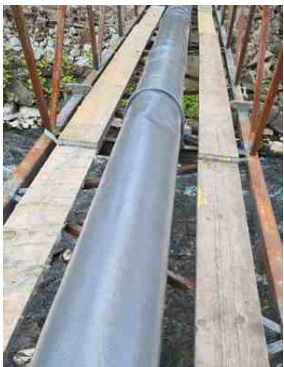
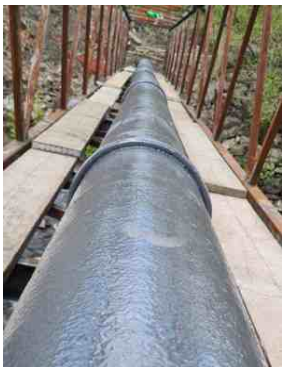
Liquid Metal was painted onto the pipe, curing to form a new, impermeable metallic outer surface

Several layers of **Liquid Metal Epoxy Coating** were then painted onto the pipe and the steel hoops and beams holding it in place, using a roller.

Once cured, Liquid Metal formed a hard-wearing, smooth, metallic, impermeable skin around the pipe. This new outer surface would prevent further corrosion and ensure fluids could no longer escape.

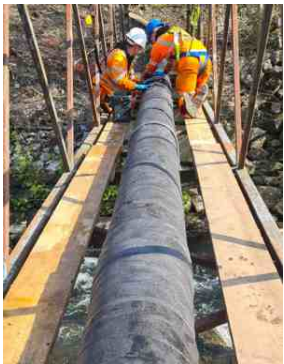
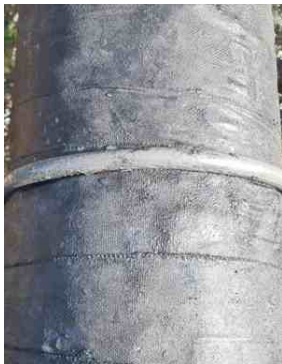
SylWrap CR was carefully applied to the whole line, providing further reinforcement and protection

To further reinforce the pipe and reinstate integral strength, the line was wrapped with four layers of **SylWrap CR Corrosion Protection Wrap**, which formed an impact-resistant protective shell.
