SYLWRAP Case Study

Corroded Shared Water Supply Pipe Repair

A 48 metre long shared water supply pipe attached to the back wall of eight cottages required repair after heavy corrosion caused leaks to appear

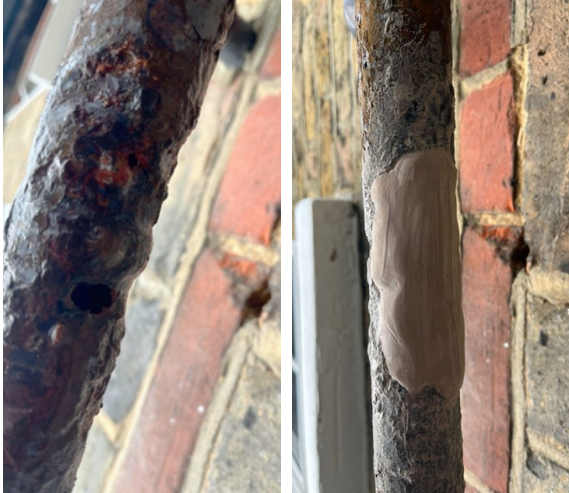
Low-quality lagging had trapped moisture against the steel pipe, causing corrosion along the whole 48 metre line and leaving to holes in multiple places.

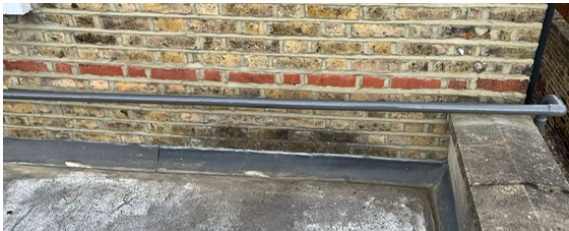
The pipe was painted in Liquid Metal to reinforce and strengthen the brittle metalwork

Liquid Metal Epoxy Coating was painted onto the two sections to form a new metallic, hard-wearing outer surface. This strengthened the pipe and acted as a shield against external corrosion.

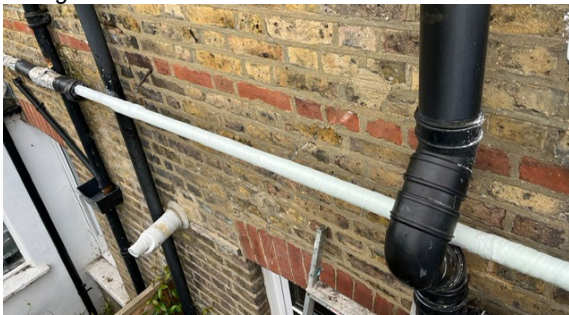
SylWrap Bandage was applied over the Liquid Metal coating, forming an impact resistant shell

Four layers of **SylWrap Pipe Repair Bandage** were then wrapped around the two sections, encompassing them with an impact resistant shell.
