# SYLWRAP Case Study

## Rainwater Stack Corroded Pipe Joint Sealing

Pipe joints in a 250-metre-long internal cast iron rainwater stack are sealed, avoiding a total system replacement during the refurbishment of an office block

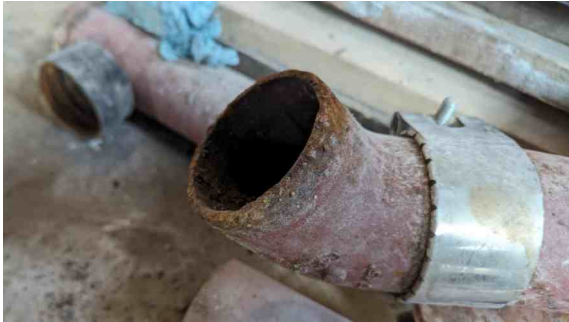
*Corrosion had left the pipe ends uneven, making it impossible to create watertight joints using clamps*

During the refurbishment of the office block, 30-year old rubber seals joining sections of the rainwater stack together were discovered to have failed.

When the seals were removed, the pipe ends beneath had been left uneven, pitted and breached by corrosion. This made achieving a watertight seal when the pipe was rejoined with repair clamps impossible.

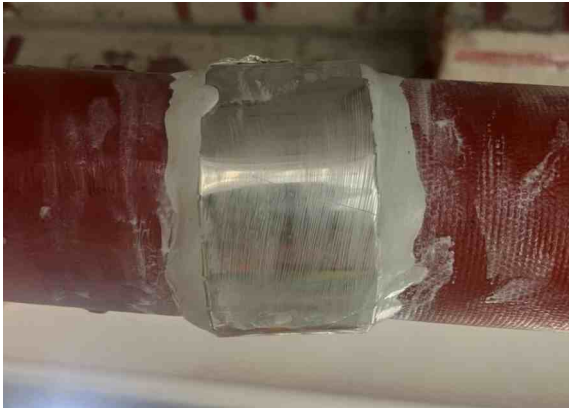
*AB Original was forced between repair clamps and the uneven pipe surface, sealing any gaps*

Sylmasta were called to the office block to see if a repair method could be formulated. It was decided to use **Sylmasta AB Original Epoxy Putty Stick** to seal the newly installed repair clamps against the pipe.

Enough putty was cut from a 200g stick and kneaded by hand. Whilst soft, it was forced into both ends of the clamp, filling all gaps between it and the uneven pipe surface.

Once hardened, AB Original permanently sealed any leak paths. The repair was so effective that the company carrying out the refurbishment decided to use it to seal all 300 joints across the entire stack.

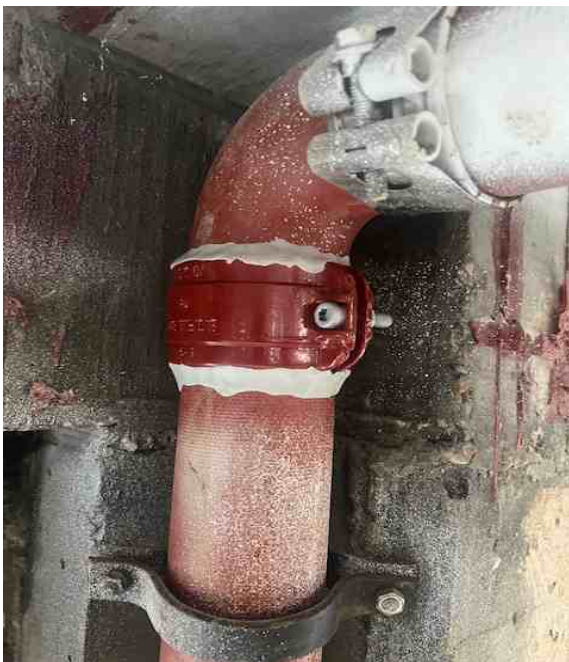
*120kg of AB Original was used to seal 300 joints in the rainwater stack before it was blocked back off*

120kg of AB Original was used for the repair. The two-hour work time allowed the engineers to thoroughly seal every joint at a reasonable pace without fear the putty would set before being properly applied.
