# SYLWRAP Case Study

## Hawaii Corroded Sewer Force Main Repair

A corroded 30-metre section of ductile iron sewer main inside an underground vault is refurbished after a previous repair put a 75mm round hole in the pipe

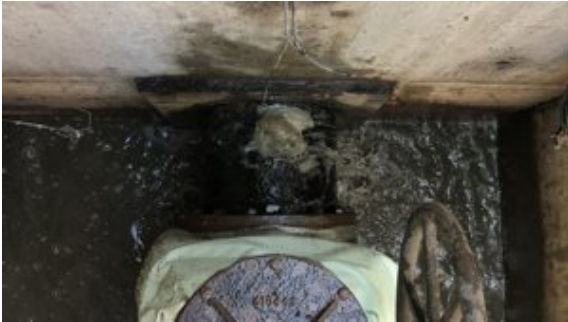
*Attempt to clean the pipe by left a hole which water escaped from when the pipe was pressurised*

Previous attempts to clean off the main sandblasted a 75mm round hole into it. The pipe was so pitted and brittle that the hole could not be repaired with a clamp.

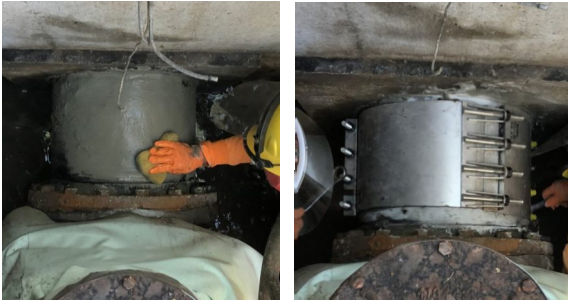
*Industrial Metal rebuilt the pipe surface around the hole to make it strong enough to withstand a clamp*

5kg of **Industrial Metal Epoxy Paste** rebuilt the pipe exterior around the hole, ensuring the line was strong and smooth enough for the clamp to be applied.

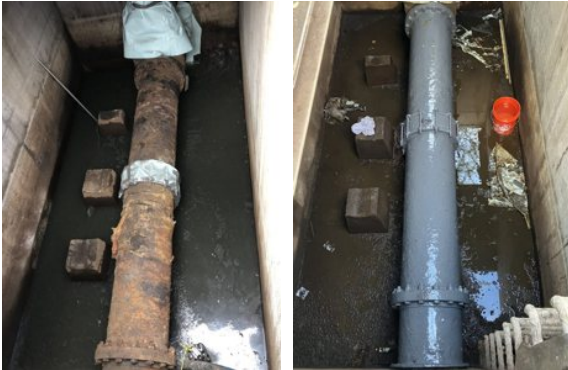
*Liquid Metal was painted over the entire main, two flanges at either end and a coupling in the middle to create a metallic external shield against corrosion*

10kg of **Liquid Metal Epoxy Coating** was painted onto the main, two flanges at either end and a coupling in the middle. It cured to create a metallic exterior shield against corrosion.

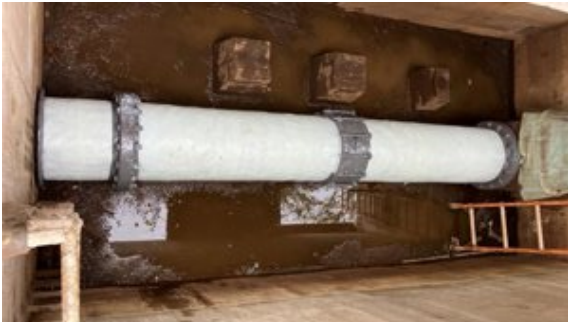
*Six layers of SylWrap HD completed the repair by forming a rock-hard, impact resistant shell*

The pipe was then reinforced with 20 x SYL866HD **SylWrap HD Pipe Repair Bandages**. Six layers were applied for a final, impact resistant layer of protection
