SYLWRAP Case Study

Biomass Plant Heating Tank Pipe Repair

A steel pipe in a confined space located at a height of over 20 feet in a farm's biomass plant heating tank required repair after being breached by debris

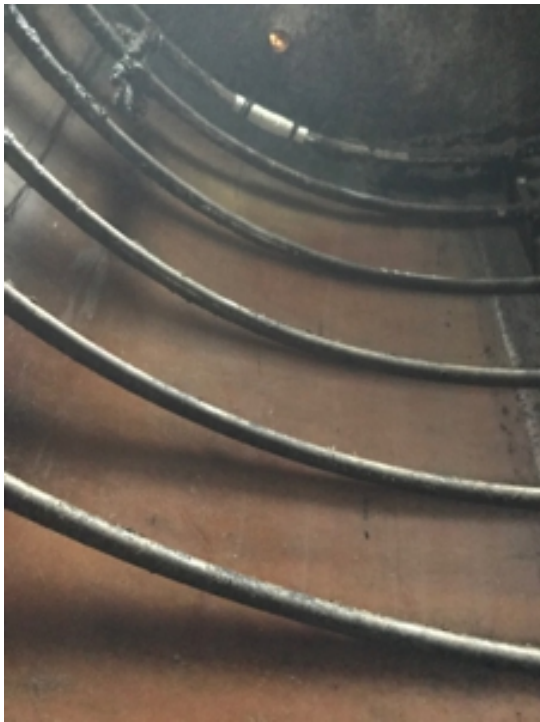
Damaged pipe located at the top of the heating tank, as seen once wrapped in SylWrap HD

The damaged stainless steel pipe was 20 feet up the inside of the heating tank. It had been breached by small pieces of farm debris dropped into the tank from an inlet directly above, inadvertently picked up as part of feedstock used in the biomass process.

Wrap & Seal Pipe Burst Tape was used to seal the initial breach, fusing into a solid rubber band providing a pressure resistant repair.

The Tape was overwrapped with **SylWrap HD Pipe Repair Bandage** for an impact-resistant, rock hard layer of protection. Both Wrap & Seal and SylWrap HD are resistant to 200°C, enabling the repair to withstand conditions within the heating tank.

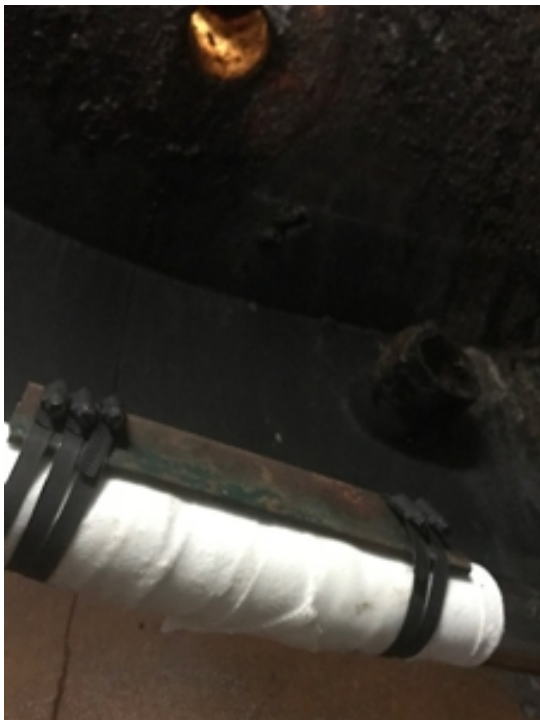
The completed repair with steel deflector plate tied to the top for added protection from future debris

To further protect the pipe from any future debris entering the tank in feedstock, a steel deflector plate was fixed to the top of the SylWrap HD
