SYLWRAP Case Study

District Heating System Pipe Repair

Two sections of pipework in a district heating system had been breached due to heavy corrosion and required a fast repair as replacement was unviable.

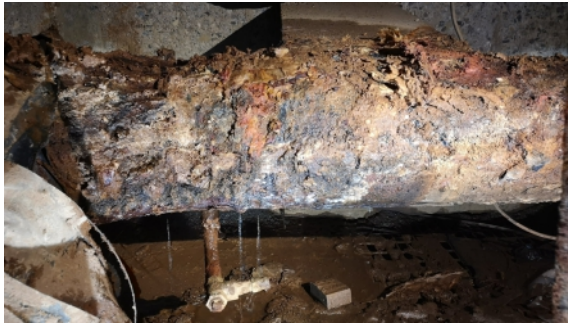
Section one of the pipe required a challenging repair around a welded joint

The system supplied heat to council-owned homes. Two sections of pipework running via underground tunnels had become breached; one from around a welded joint and the other in a 'low spot' of the tunnel which remained flooded for prolonged periods, effectively leaving the pipe underwater.

The tight work space meant a flexible repair was required. **Wrap & Seal Pipe Burst Tape** was used to provide a high-pressure seal to the breaches in the pipe, including around the welded joint.

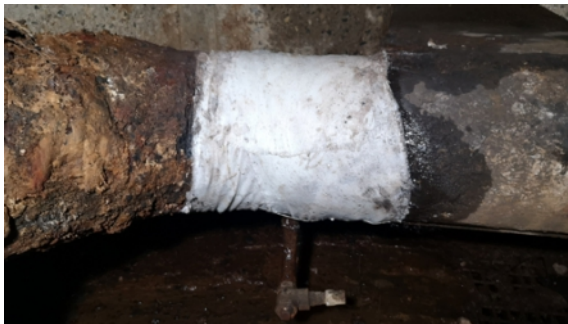
Repair to the section of pipe with the welded joint

SylWrap HD Pipe Repair Bandage was then wrapped over the Tape for a protective shell against future corrosion, damage and flooding. The repair was temperature resistant to 200°C.

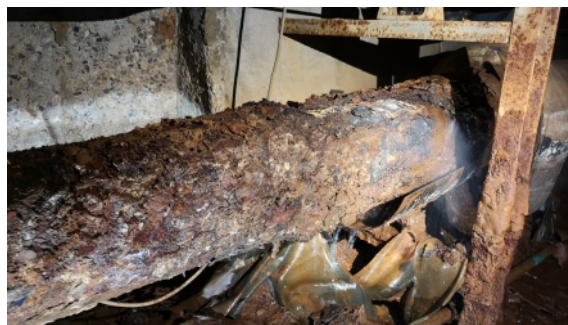
Section two of the pipe was breached underneath

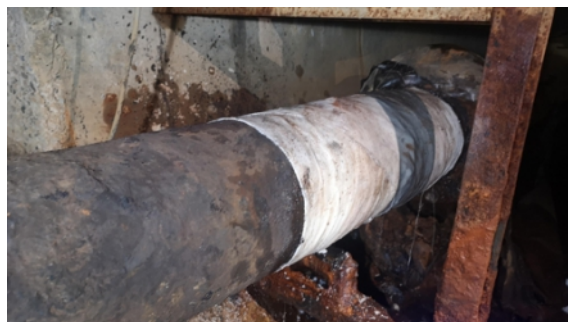
Section two of the pipe repaired and protected with an overwrapping of SylWrap HD
