SYLWRAP Case Study

Domestic Copper Pipe Joint Repair

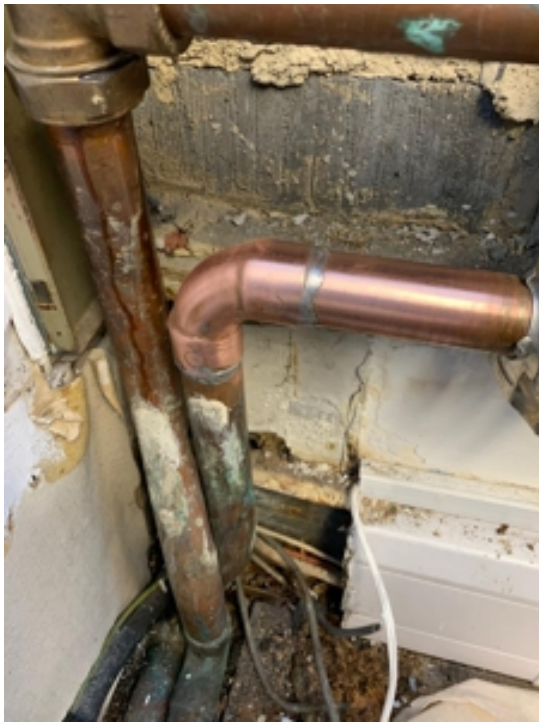
The copper pipe having been polished but prior to the application of Wrap & Seal

Poor soldering had caused a 22mm copper perimeter heating pipe at a domestic property to leak. The pipe had been boxed in behind a grill.

The property owner cleaned the pipe before applying **Wrap & Seal Pipe Burst Tape**.

In this case, it was wound tightly around the leaking joint, where it formed a solid rubber band to seal the leak.

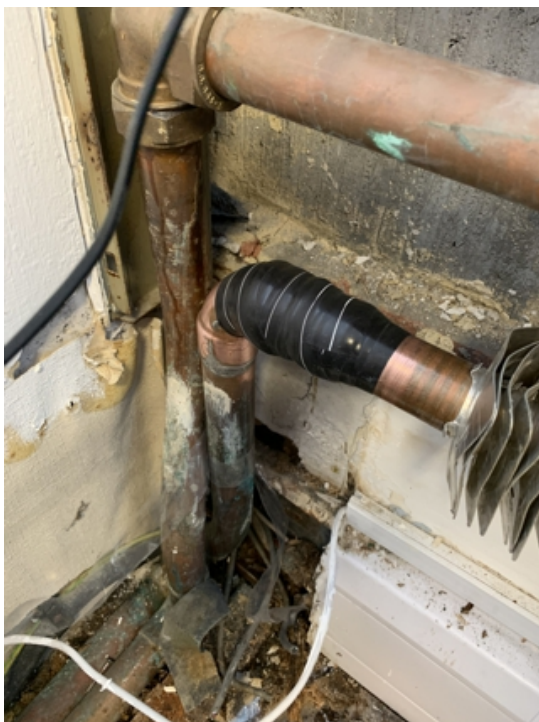
Completed repair with Wrap & Seal tightly applied over the leak area, sealing the joint

The repair was completed in under 30 minutes, preventing any more escaping water from damaging the wood surrounding the pipe.
