SYLWRAP Case Study

Extending the Lifespan of 20m Pipe Bridges

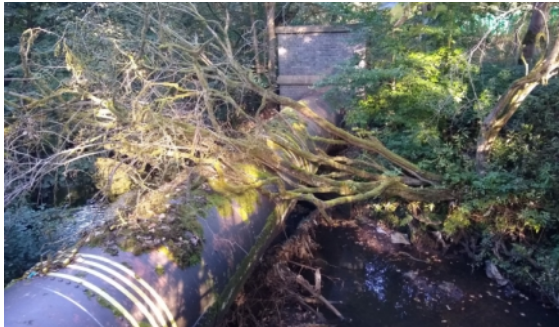
One of the 20m pipe bridges requiring repair

The 1.5m x 20m and 1.8m x 20m gravity-fed pipe bridges were constructed of steel riveted plates which had become corroded. These were leaking sewage water into a stream from numerous points.

Multiple **Wrap & Seal Pipe Burst Tapes** were applied around the numerous leak points, where the self-amalgamating silicone tape provided a tight rubber seal.

Once all leaks had been addressed, the bridges were wrapped with **SylWrap HD Pipe Repair Bandage**. Four layers of SYL1266HD (300mm x 20m) were applied along the 20m length, providing a rock-hard, impact resistant layer of protection to guard against future leaks and corrosion.

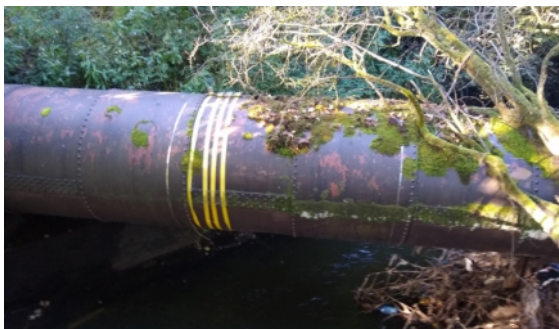
Yellow tape shows a previously failed repair attempt

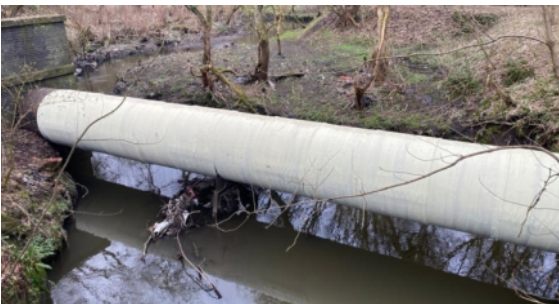
Pipe bridge wrapped along 20m length with SylWrap

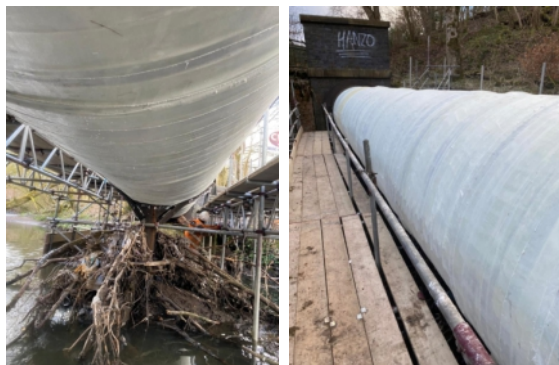
Completed repair, seen from underneath pipe bridge and from the scaffold constructed for application

Although the company responsible for the bridges initially only wanted a temporary solution until the planned replacements, the repair provided additional strength which will last for up to 20 years.
