# SYLWRAP Case Study

## Quarry Wash Plant 300mm Plastic Pipe Repair

A 300mm plastic pipe pierced during day-to-day operations in a quarry wash plant undergoes a leak repair using a SylWrap Standard Pipe Repair Kit

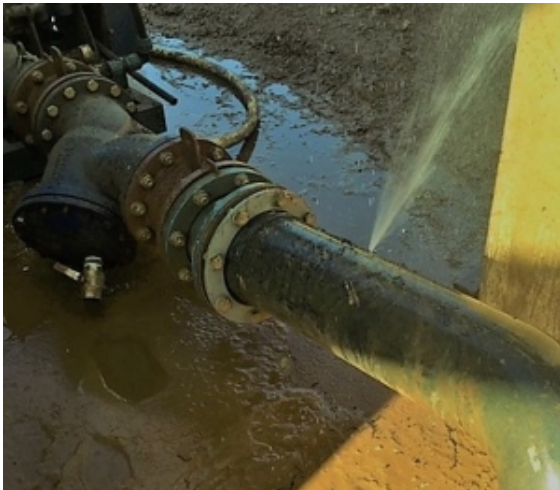
*Jet of pressurised water escaping from the pinhole leak caused by a pierce to the plastic pipe*

The 300mm plastic pipe fed the aggregate wash plant in the quarry. Once it became pierced, a highly pressurised jet of water began shooting from the pipe.

The quarry were supplied with a **SylWrap Standard Pipe Repair Kit**, which enables any user to fix a leaking pipe if pressure can be turned off.

**Superfast Copper Epoxy Stick** was used to seal the leak. The putty was kneaded by hand and pushed into the pinhole whilst soft, where it hardened to fill the breach.

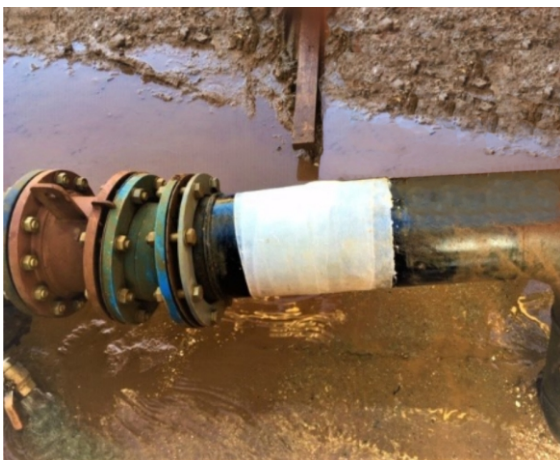
*The completed repair reinforced with a SYL633HD SylWrap Pipe Repair Bandage*

A SYL633HD **SylWrap HD Pipe Repair Bandage** was applied over the top of the putty, providing an impact resistant layer of protection and creating a repair with pressure resistance up to 30 bar.

Within one hour, the repair was completed and the plastic pipe put back into service.
