SYLWRAP Case Study

Sulphuric Acid Line Elbow Reinforcement

An elbow on a 100mm sulphuric acid line required urgent reinforcement after it was discovered to have degraded from 22mm thickness to just 1mm

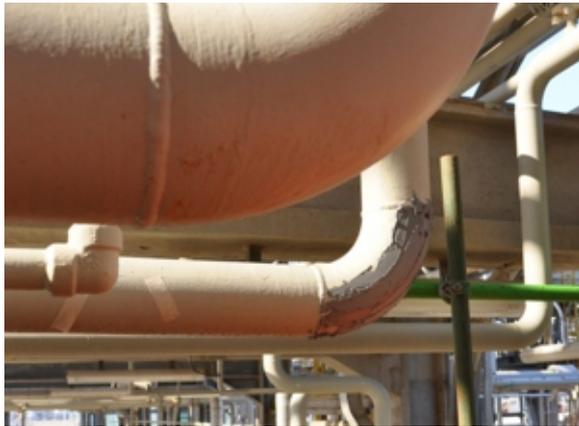
The weakened elbow joint was coated with Industrial Metal Epoxy paste for reinforcement

Industrial Metal Epoxy Paste was applied with a hand tool. It cured to form an outer shell surrounding the elbow. If the original line was now breached, its contents would be contained by a casing with high corrosion and chemical resistance.

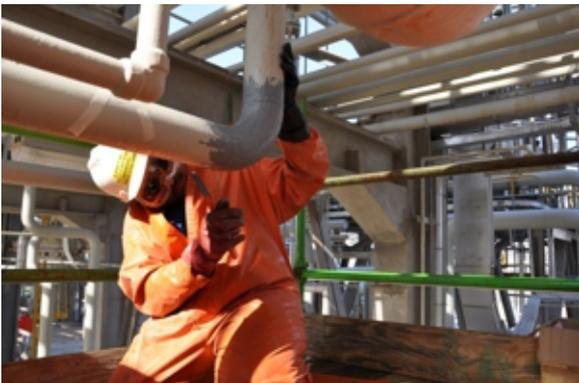
Industrial Metal was applied via a hand tool by an engineer to encompass the entire elbow

The line normally operated under 22 bar pressure. This was reduced to 8 bar during the application.

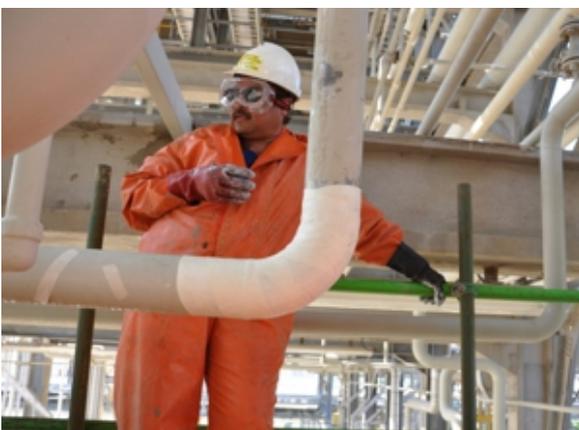
SylWrap HD was used to complete the repair, setting rock hard for an impact resistant layer of protection

A SylWrap HD Pipe Repair Bandage was then applied over the Industrial Metal. This provided further reinforcement to the pipe by creating an impact resistant layer and increasing hoop strength.

24 hours after the application and the line was back fully operational at 22 bar pressure.

Inspections of the elbow over the next two years showed that there had been little to no decrease in the strength of the repair, allowing the refinery to further delay the installation of a replacement line.
