SYLWRAP Case Study

Bahrain Airport Leaking Step Joint Repair

Bahrain International Airport required a live leak repair method for a step joint on a 100mm UPVC pipe so that a shutdown of systems could be avoided

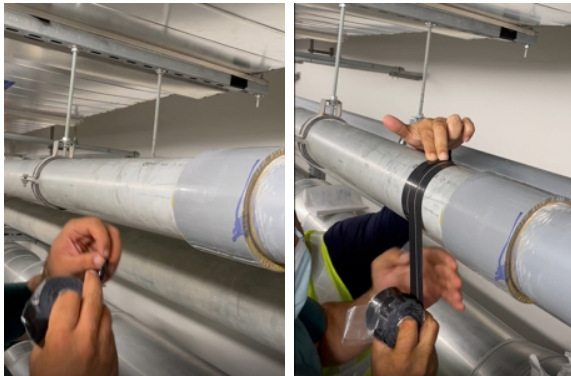
The pipe was leaking from the left hand side of the joint with the application of Wrap & Seal starting 100mm away to build up a ridge towards the step

Solvent cement bonds holding the pipe together had begun to weaken, allowing water to seep out through a step joint connecting two sections.

As this was a live leak, **Wrap & Seal Pipe Burst Tape** had to be used. To create a repair capable of sealing the step, wrapping began some 100mm away from the joint with a 50% overlay.

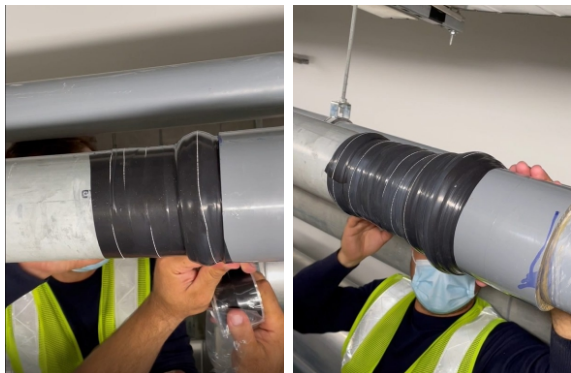
Once the ridge reached level height with the step, wrapping continued to encompass the joint

After reaching the step, layers of Tape were built up next to it, creating a ridge. Once the ridge was level height with the step, wrapping continued for 50mm across the step, encompassing the whole joint.

Two 50mm x 4m Tapes were required to completely seal the leak, self-fusing to each other to form a solid rubber band.

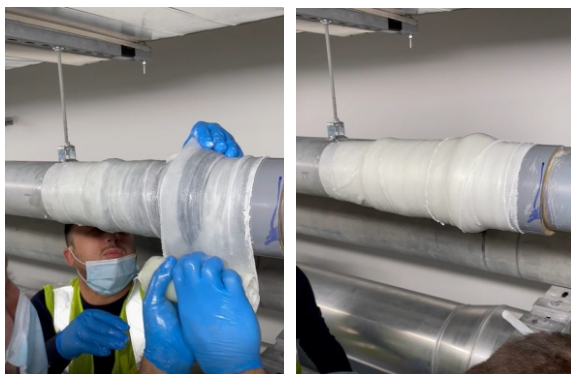
SylWrap HD provided a rock hard, protective sleeve to complete the repair

A **SylWrap HD Pipe Repair Bandage** was then wrapped over the entire repair, providing an impact resistant, protective shell.
