SYLWRAP Case Study

Pharmaceutical Plant Corroded Tank Repair

A pharmaceutical plant in Puerto Rico sought a method for repairing a badly corroded industrial tank to keep it operational until a scheduled replacement

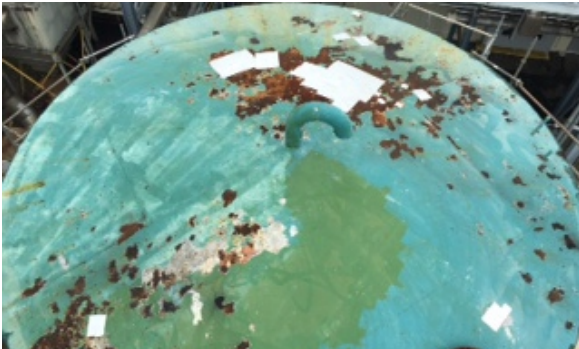
E190 Brushable Epoxy was coated onto **Fibreglass Tape** to patch repair the cracks in the tank

These holes were bridged using strips of **Fibreglass Tape** soaked in **Sylmasta E190 Brushable Epoxy** and layered over each hole to build a composite patch repair.

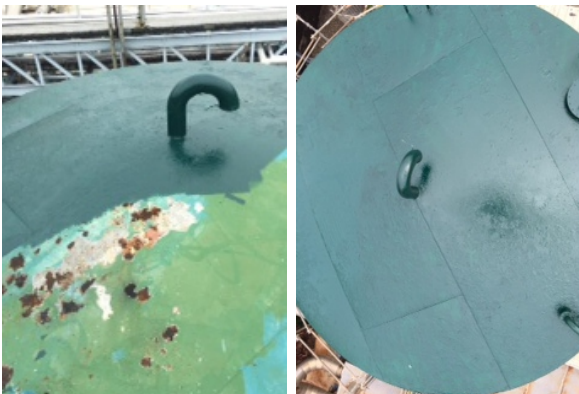
Ceramic Brushable Green coated onto the tank to provide a surface resistant to corrosion and abrasion

Once each hole had been arrested, the tank was covered in three coatings of **Ceramic Brushable Green** with a re-coat time of four hours.

Ceramic Brushable fully cured 24 hours after the final coat was applied. The entire repair took a little under two days to complete.
