SYLWRAP Case Study

Power Station Contaminated Water Pipe Repair

A SylWrap live leak repair in 2015 to a cracked steel contaminated water pipe in a Puerto Rican Power Station ensured that the facility was operating at full capacity when Hurricane Maria devastated the island 18 months later

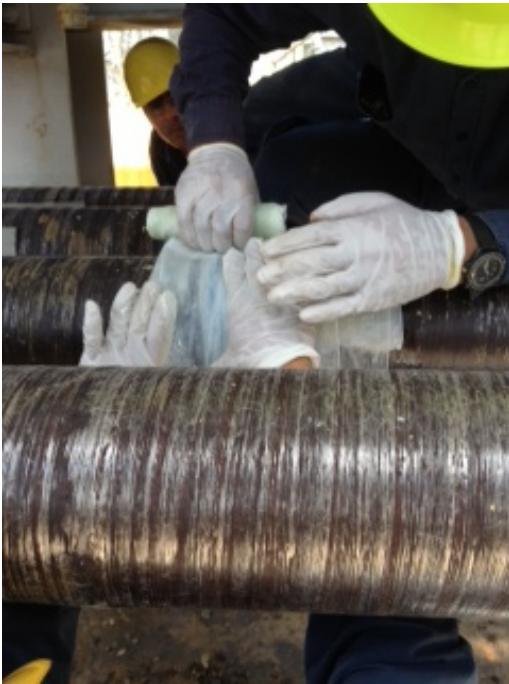
SylWrap HD is applied after the crack had been sealed using Wrap & Seal

A crack in a steel pipe carrying contaminated water from one of the power station's generators to an on-site treatment plant had undergone several failed repair attempts.

Using a **SylWrap Universal Pipe Repair Kit**, the Plant were able to seal the crack in the pipe with **Wrap & Seal Pipe Burst Tape**.

This was then overwrapped with a **SylWrap HD Pipe Repair Bandage**, providing an impact resistant layer to the initial repair.

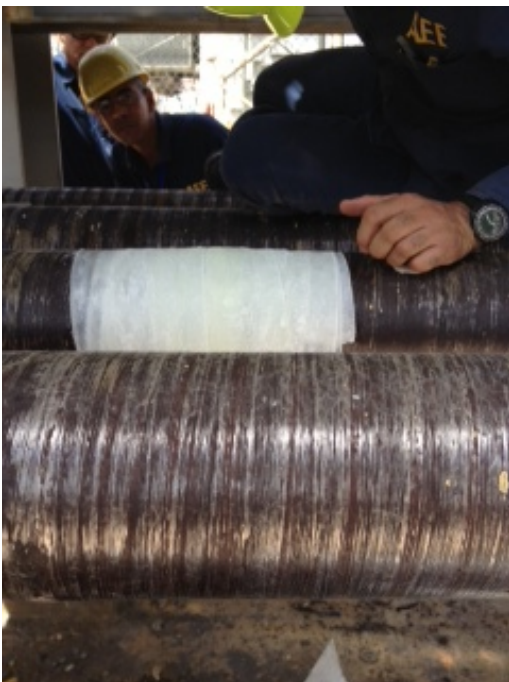
The completed repair enabled the Power Station to operate at full capacity after Hurricane Maria hit Puerto Rico

Within an hour of the repair, the generator was put back into service and the power station was running at full capacity again.
