# SYLWRAP Case Study

## Fire Station Corroded Steel Pipe Reinforcement

A six metre section of 150mm steel pipe including two elbow bends in a fire station pumping house is reinforced before corrosion could breach the line

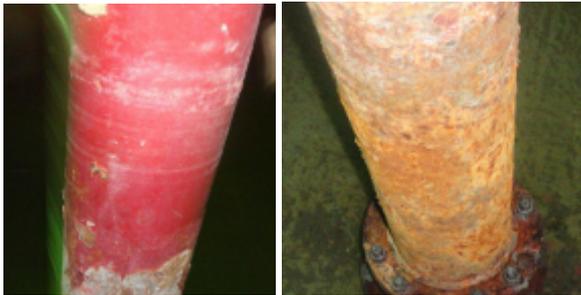
Lower sections of the pipe were badly corroded

Heavy corrosion had developed after many years service, especially on the section of pipe beneath the surface of the reservoir. It was now only a matter of time before the line was breached.

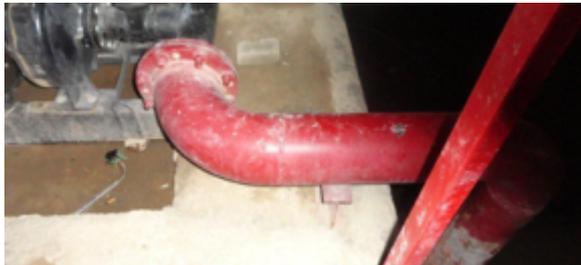
Upper level of the pipe before reinforcement began

Starting from the upper level and working down, **SylWrap HD Pipe Repair Bandage** was wrapped along the six metre length of the pipe.

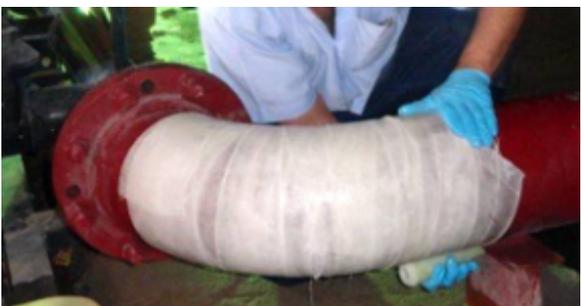
SylWrap HD applied to an elbow bend

SylWrap is easily moulded around complex shapes and can be applied underwater, enabling it to reinforce both the bends and the section of pipe passing through the reservoir.

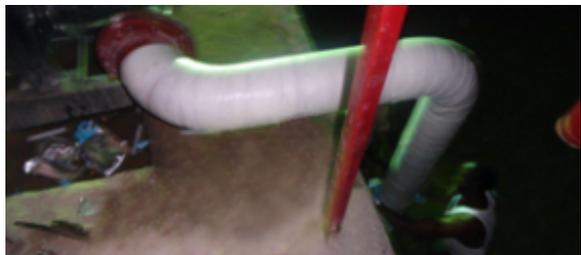
Top section - including the two bends - reinforced

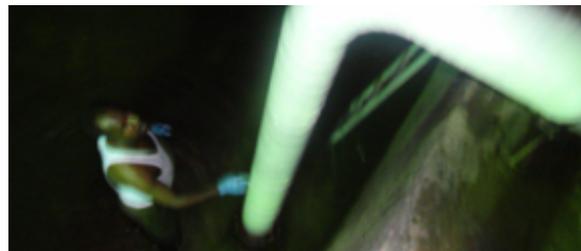
Completed reinforcement of the bottom section

Once cured, SylWrap formed a rock hard shell encompassing the entire line. This protected the pipe from further corrosion.
