SYLWRAP Case Study

Reinforcing Welded Corners in Acid Tank

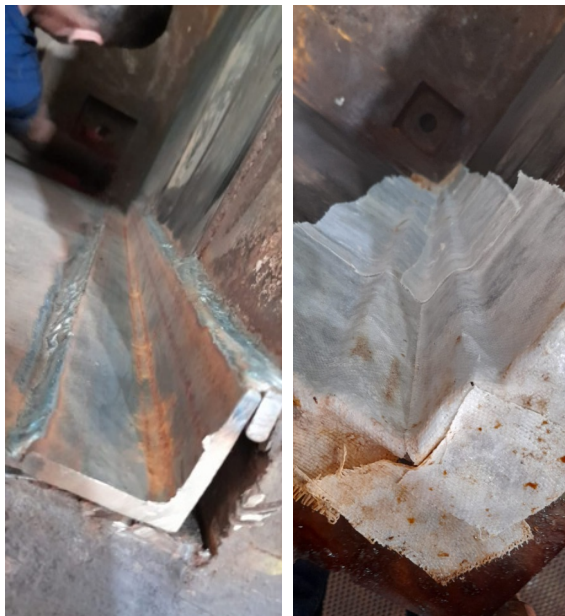
New metal corners were welded to reinforce all four corners of the chromic acid tank. These corners were then encompassed with SylWrap HD

The factory unwound and cut a **SylWrap HD Pipe Repair Bandage** into patches, making sure not to contaminate the bandage with dirt or grime.

These patches were activated with water and pressed and smoothed tightly up the entire length of welded reinforcement in all four corners.

SylWrap HD cured within 10 minutes to form a rock-hard shield, creating a watertight seal between each weld and the frame of the tank and covering any gaps or holes otherwise left exposed.

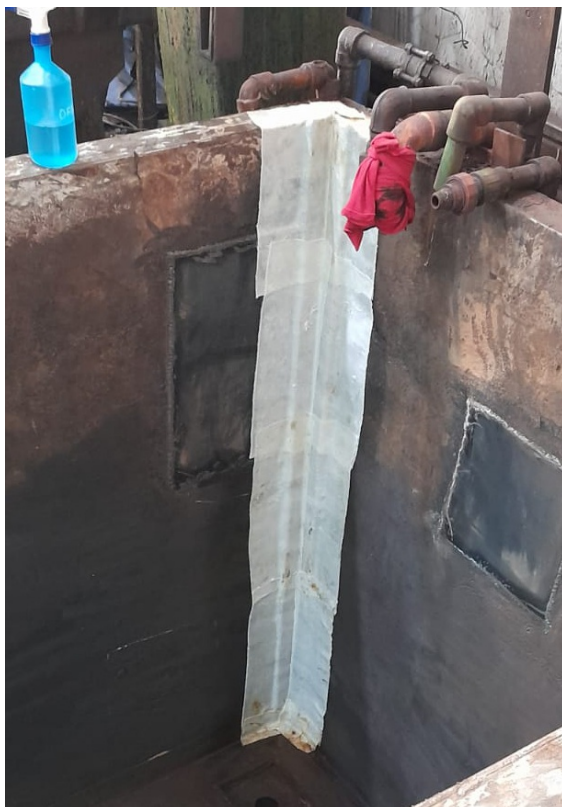
Patches of SylWrap pressed and smoothed over each corner created a watertight seal between the weld and the existing iron frame of the tank
