SYLWRAP Case Study

Cement Coated Steel Pipe Live Leak Repair

A cement coated steel pipe on a water network in Mexico undergoes a live leak repair after the removal of the outer coating revealed a split in the line

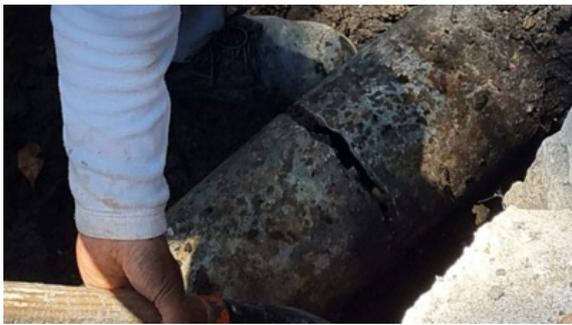
A 15mm crack was discovered in the cement coating of the pipe, although no leakage was detected

A potential leak was identified on a cement coated steel pipe running beneath a street. Excavation of the line revealed a 15mm wide crack across the diameter of the outer coating of the pipe.

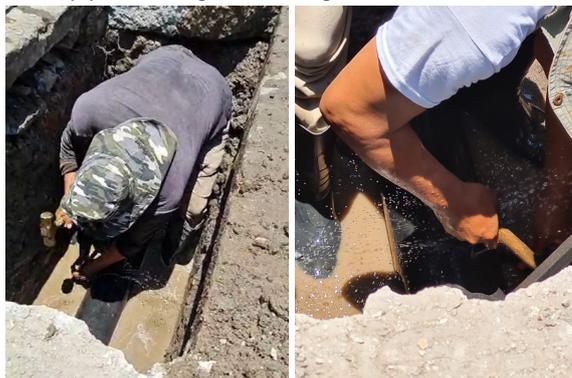
As the cement coating was removed, water began spraying from a 80mm long split in the steel pipe

There was no sign of leakage through the crack. To inspect the condition of the steel inside, the cement was removed. As the coating was cut away, water began spraying from a 80mm long split in the pipe.

With no means of isolating this section of the water network, the only option was a live leak repair.

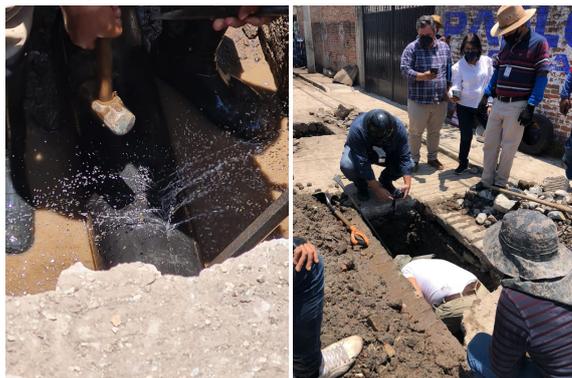
Once the coating had been fully removed, the steel pipe was sealed using a SylWrap Contractor Case

The company who detected the leak and excavated the pipe equips all its engineers with a **SylWrap Pipe Repair Contractor Case**, meaning everything needed to repair the pipe was already on-site.

Wrap & Seal Pipe Burst Tape was used to seal the pipe. Multiple Tapes were wrapped up the length of the split until the leak had been arrested via the building of a repair resistant to 3bar.

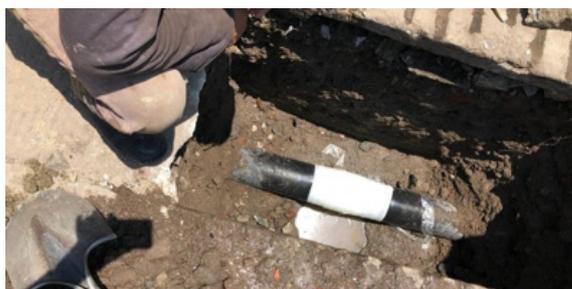
After the leak was sealed with Wrap & Seal, SylWrap HD provided an effective replacement for the coating

A **SylWrap HD Pipe Repair Bandage** was then wrapped and smoothed over the pipe. It set rock hard in minutes, providing an impact resistant sleeve to replace the removed cement coating.
