SYLWRAP Case Study

Boat Engine Leaking Rubber Hose Repair

A rubber hose connected to a boat engine undergoes repair after developing a pinhole leak in an area of the vessel which was extremely difficult to access

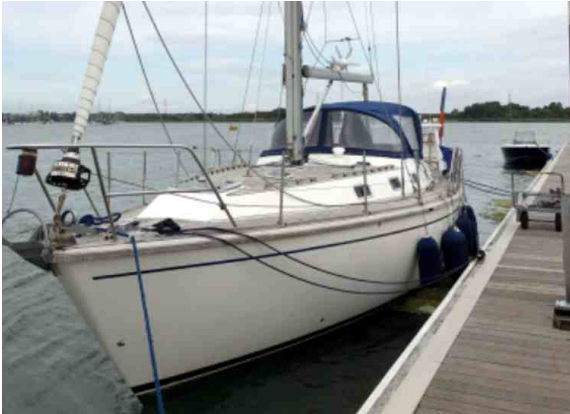
The boat could not sail safely whilst the hose leaked

The hose carried water as part of the cooling process, which was spraying out of the pinhole at high pressure whenever the engine was in service.

Repairing this dangerous leak was made difficult as the hose was in a confined space below deck, surrounded by other pipes and engine components.

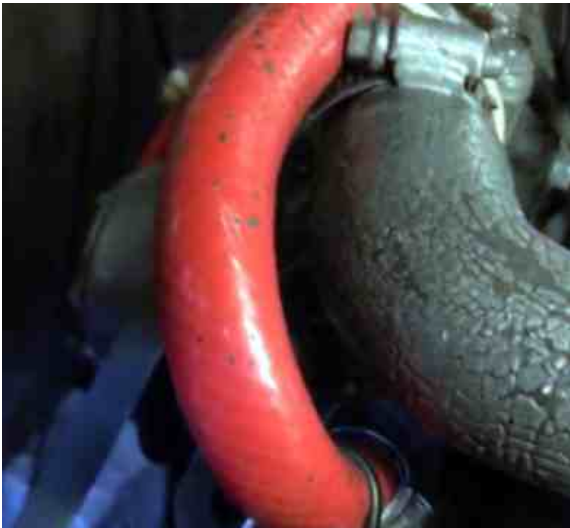
The pinhole was on a section of red coloured rubber pipe where access was severely restricted

First, the pinhole was sealed with **Superfast Steel Epoxy Putty**. The putty was kneaded by hand and applied over the leak area whilst soft.

It was then overwrapped with a **SylWrap Pipe Repair Bandage**. As the SylWrap Bandage was wrapped and smoothed around the hose, it forced the putty further into the pinhole as it cured, completely sealing the leak.

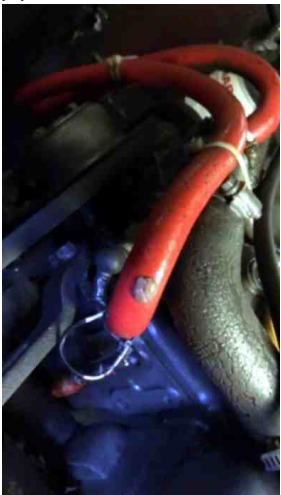
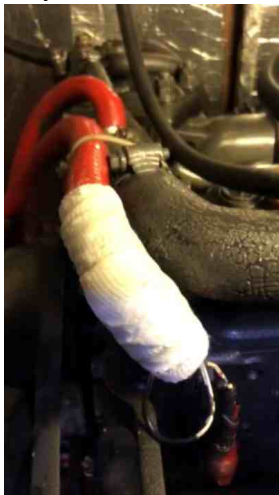
Superfast Steel was applied to the pinhole, followed by a SylWrap Pipe Repair Bandage to seal the leak

After both Superfast Steel and SylWrap Bandage had set, a permanent repair with pressure resistance up to 30 bar and temperature resistance to 120°C had been created.

When the boat engine was started, no water was escaping from the hose. This indicated a successful repair and meant the vessel could return to the sea.
