# SYLWRAP Case Study

## Cement Coated Steel Pipe Live Leak Repair

A cement coated steel pipe on a water network in Mexico undergoes live leak repair after removal of the outer coating revealed a 80mm long split in the line

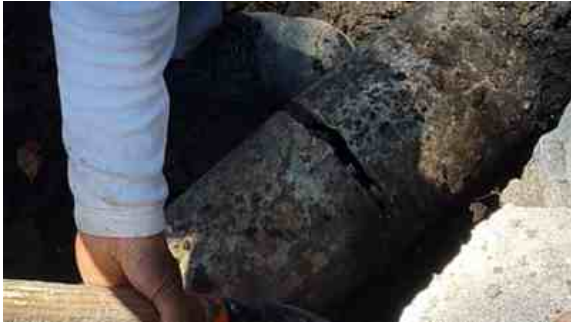
A 15mm crack was discovered in the cement coating of the pipe, although no leakage was detected

A potential leak was identified on a cement coated steel pipe running beneath a street. Excavation of the line revealed a 15mm wide crack across the diameter of the outer coating of the pipe.

There was no sign of leakage through the crack. To inspect the condition of the steel inside, the cement was removed. As the coating was cut away, water began spraying from a 80mm long split in the pipe.

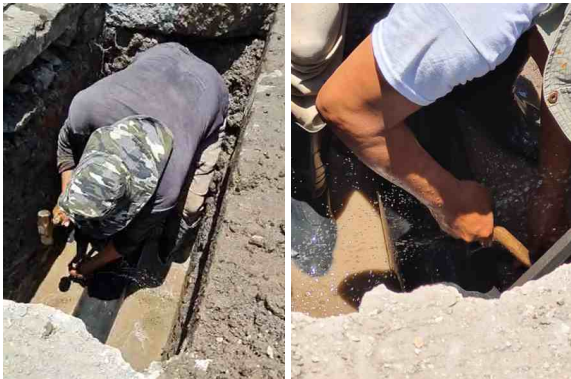
With no means of isolating this section of the water network, the only option was a live leak repair.

As the cement coating was removed, water began spraying from a 80mm long split in the steel pipe

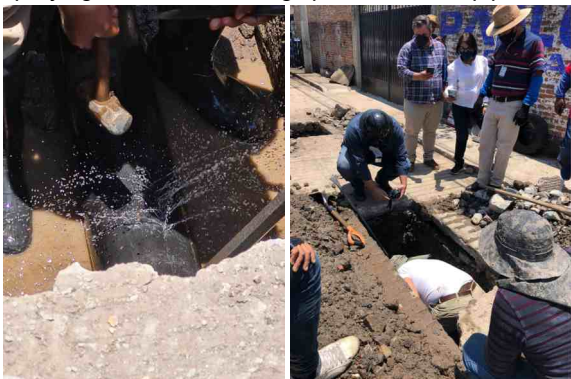
Once the coating had been fully removed, the steel pipe was sealed using a SylWrap Contractor Case

**Wrap & Seal Pipe Burst Tape** was used to seal the pipe. Multiple Tapes were wrapped up the length of the split until the leak had been arrested via the building of a repair resistant to 3bar.

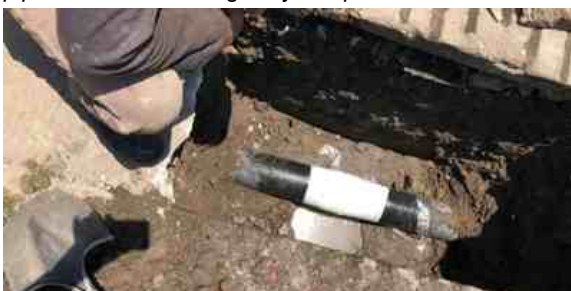
After the leak was sealed with Wrap & Seal, SylWrap Bandage replaced the protective concrete coating

A **SylWrap Pipe Repair Bandage** was then wrapped and smoothed over the pipe. It set rock hard in minutes, providing an impact resistant sleeve to replace the removed cement coating.
