SYLWRAP Case Study

Biodigester Tank Steel Heating Pipe Repair

A pig farm seal a leaking stainless steel heating pipe inside a biodigester tank after an initial repair made via patch welding was discovered to have failed

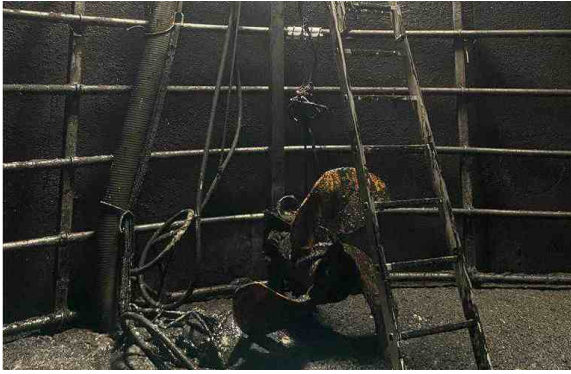
Propeller mixer blade was attached to a metal pillar inside the biodigester tank which had moved back to collide with a steel heating pipe, causing a breach

Over time, the mixer blade pushed the pillar backwards to the point where it collided with one of the heating pipes, causing a breach in the steel.

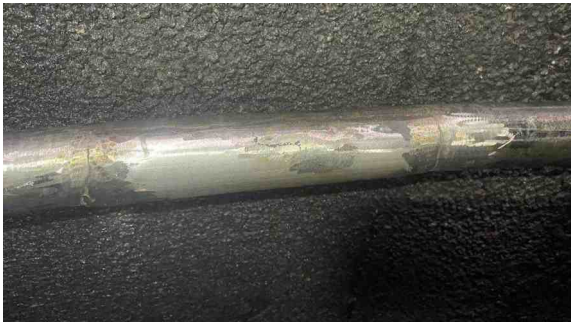
An initial repair attempt involving patch welding failed, leaving multiple pinhole leaks in the pipe

When the biodigester began underperforming again, another inspection revealed water sprouting from multiple pinholes in the patch welding.

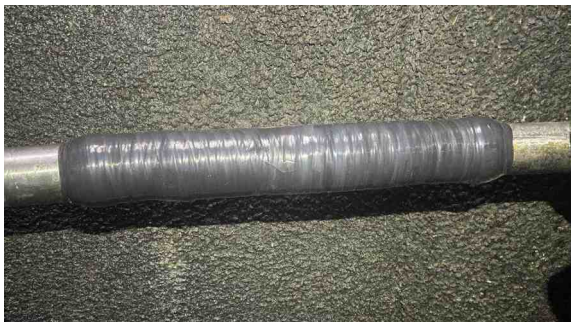
Wrap & Seal was applied along the entire 600mm length of the area which had been patch welded

A **SylWrap Universal Pipe Repair Kit** was used by the farm for the second repair attempt. The pipe was cleaned and the patch weld ground down.

Wrap & Seal Pipe Burst Tape was wrapped across the length of the 600mm area which had been patch welded, sealing all pinholes in the pipe.

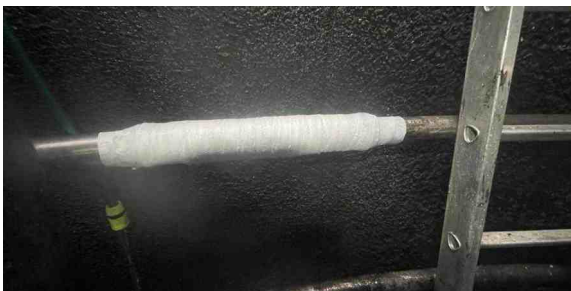
SylWrap Bandage encompassed the repair with a rockhard shield to protect against future impact from the pillar and mixer blade

To reinforce and protect the repair, **SylWrap Pipe Repair Bandage** was applied to encompass the pipe with a rock-hard, impact resistant sleeve.
