Epoxy Putty Case Study

Gas Plant Seawater Storage Tank Repair

The floor of a seawater storage tank undergoes repair after gaps appeared between rubber matting, leaving the concrete coating below exposed

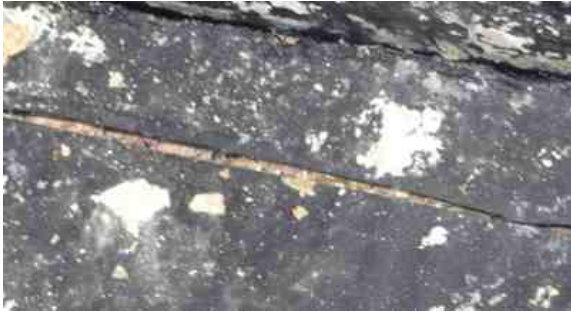
Gaps had appeared in the rubber matting, exposing the concrete lining of the tank to seawater

Problems with the tank led to it being drained. The floor matting was found to have loosened, lifted and broken apart in places, leaving exposed concrete.

Before the tank could go back into service, all gaps in the matting needed to be sealed to reduce the risk of seawater passing through the concrete and corroding the metal frame.

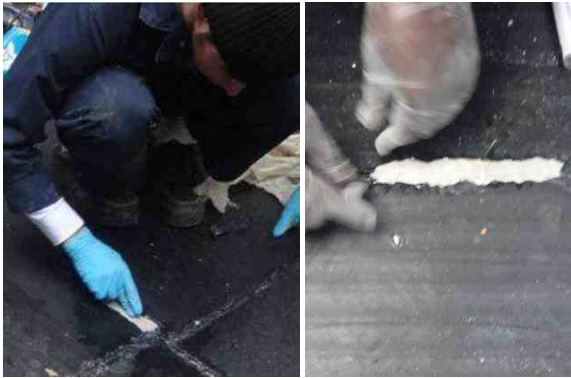
AB Original was pushed into each gap before being smoothed off with water and a hand tool

Sylmasta AB Original Epoxy Putty was kneaded by hand and forced into the gaps between the rubber sheeting whilst soft. It was then smoothed off with water and a hand tool and left to harden.

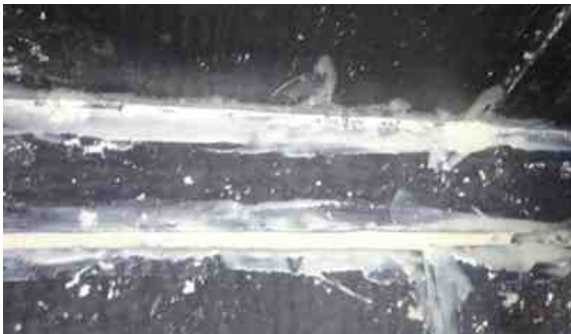
Once cured, AB formed a waterproof material sealing every gap and protecting the concrete lining beneath

Once cured, AB Original formed a waterproof material offering high chemical and corrosion resistance, permanently filling every gap and protecting the concrete from seawater exposure.

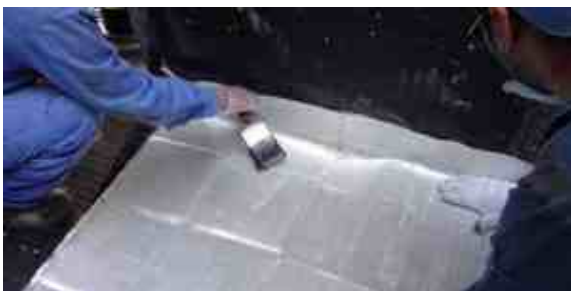
Fibreglass sheets were layered over the matting and coated with epoxy resin to create a new reinforced floor surface

To finish the repair, fibreglass sheets were layered over the matting and coated with an epoxy resin to create a new reinforced floor surface.
