# SYLWRAP Case Study

## Live Leak Pipe Repairs on Libya Water Network

Above and below ground water pipes servicing a town in Libya undergo live leak repair to seal cracks through which high levels of water were escaping

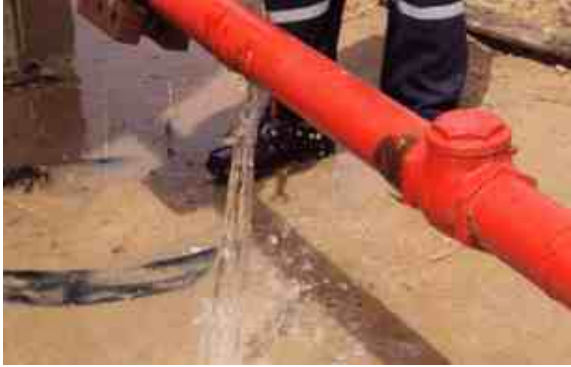
*Significant levels of water were escaping the above-ground section of pipe at 5 bar pressure from a longitudinal split*

The 100mm pipes were part of the network supplying water to the town of Brega, operating at 5 bar.

When a longitudinal split then developed in an above-ground pipe, a blind eye could no longer be turned to problems on the network. It was decided to find a way to repair both pipes.

For the above-ground pipe, **Wrap & Seal Pipe Burst Tape** was wrapped along the length of the split.

Multiple Tapes were applied over each other until no water was leaking, indicating the repair had reached 5 bar pressure resistance. A **SylWrap Pipe Repair Bandage** was then applied to protect the Tape.

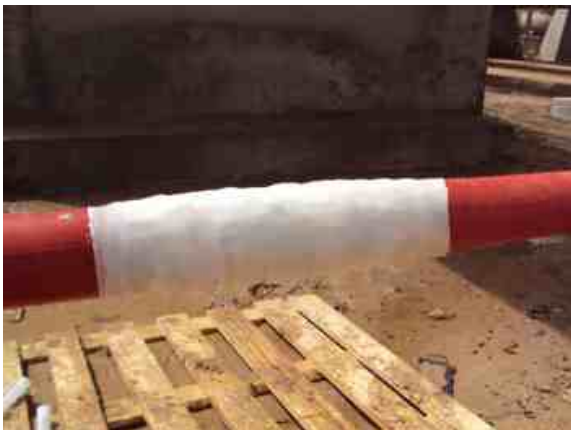
*The above-ground section was successfully sealed using Wrap & Seal and then further protected with SylWrap Pipe Repair Bandage*

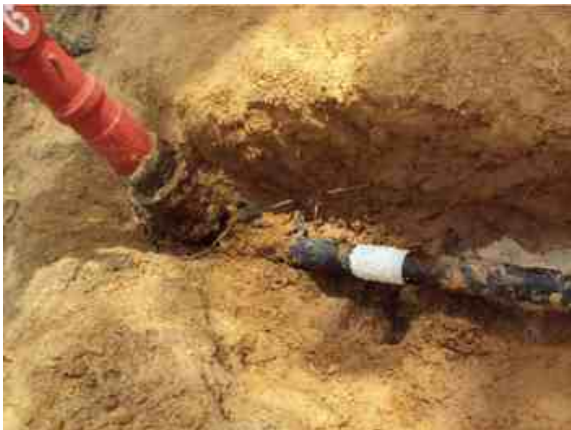
An underground section was first identified as leaking through visible signs in earth surrounding the pipe. This leak was initially ignored because a repair or replacement was considered too difficult.

*A trench was dug with enough clearance to reach the below-ground section of pipe. It was then repaired using Wrap & Seal and SylWrap Bandage*

A trench was dug to reach the below-ground section with enough clearance to wrap both Wrap & Seal and SylWrap around the pipe. The small crack in the pipe was easily arrested.
