SYLWRAP Case Study

Power Station Hydrogen Line Pipe Repair

Two leaking joints on a 600mm section of hydrogen line at a power station in Puerto Rico required sealing before a new cooling system could go online

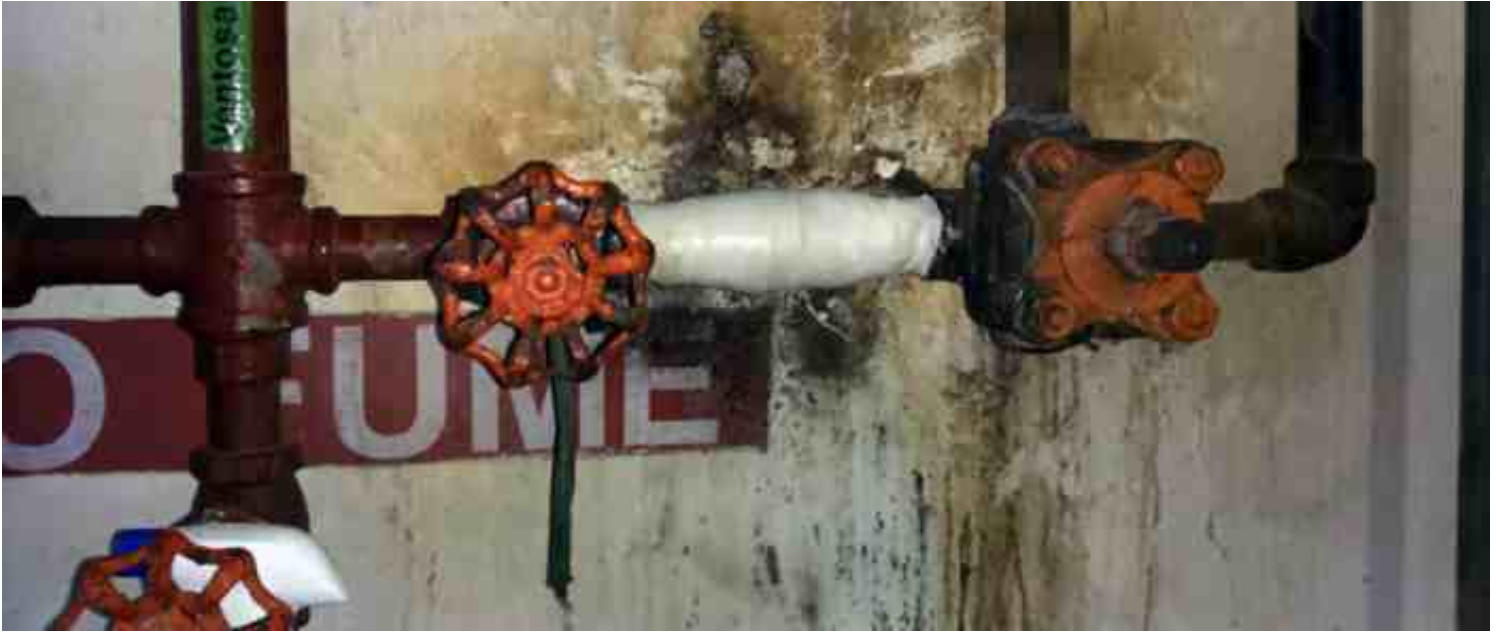
Pipes took hydrogen from the new generator to where it was required. Prior to the system being put into service, hydrogen detectors were used to test for leaks. A 600mm section of pipe was found to be leaking, suspected from two joints between two valves.

Although the leaks posed little threat, the station decided to repair and reinforce the line. The pipe was isolated and **Superfast Steel Epoxy Putty Stick** pushed tightly onto the pipe around both joints. The putty cured to form a steel-like material, plugging any gaps through which hydrogen could be escaping.

The entire line was then wrapped in a **SylWrap Pipe Repair Bandage**. Once cured, SylWrap Bandage provided a rock hard, impact resistant sleeve encompassing the pipe.

24 hours after the repair and the line was repressurised. The hydrogen detectors could find no gas in the air, indicating the application had been a success. The new cooling system was then put into full service.
