SUPERFAST
PLASTIC STICK

Case Study

Bathroom Sink PVC Plastic Drain Pipe Repair

Cracks in a PVC plastic pipe located in a cupboard underneath a bathroom sink undergo a quick, easy and inexpensive DIY repair by the homeowner

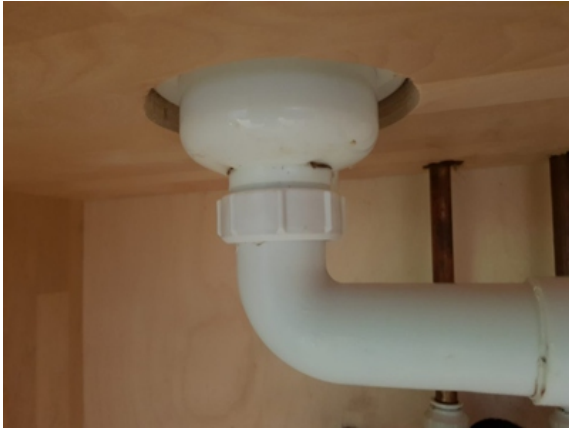
Cracks had appeared in the top of the PVC plastic drain pipe where it connected to the sink

The homeowner realised there was a problem when they noticed the bathroom floor next to the cupboard was wet.

After inspecting inside the cupboard, several cracks were noticed in the plastic drain pipe at the point it connected with the sink.

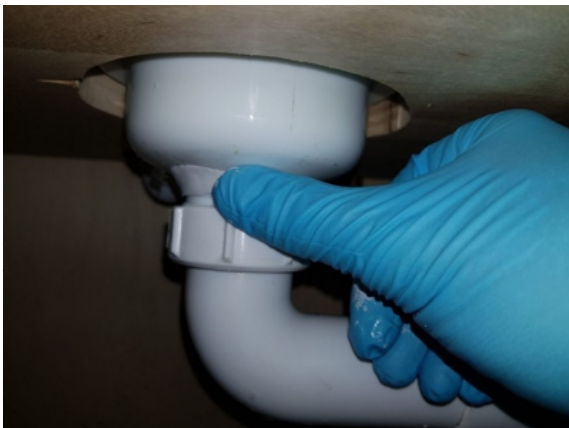
Superfast Plastic was kneaded by hand, formed into a sausage shape and pushed over the cracks in the pipe whilst the putty remained soft

A **Superfast Plastic Epoxy Putty Stick** was used to make a quick, easy and permanent repair. The pipe was dried and cleaned before the application.

The required amount of putty was then cut from the stick and kneaded by hand, turning from blue to white to indicate successful mixing.

Whilst soft, the putty was formed into a sausage-like shape and pushed against the pipe, covering all the holes.

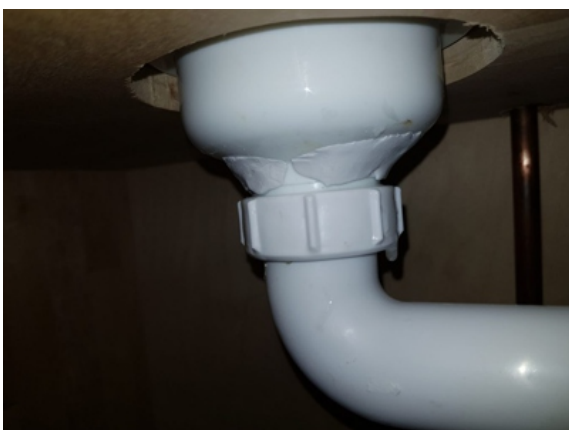
The putty hardened, permanently sealing the cracks in the pipe and preventing any more water from escaping when the sink drained

After 25 minutes it began to harden. Within 45 minutes, the putty had cured to provide a watertight seal, filling all holes in the pipe.

Superfast Plastic achieved full properties after two hours, at which point the homeowner ran the tap.

No water escaped the pipe as the sink drained, indicating a successful repair at a total cost including delivery of under £20.
