Wrap & Seal Case Study

PIPE BURST TAPE Toilet Soil Pipe Hairline Crack Repair

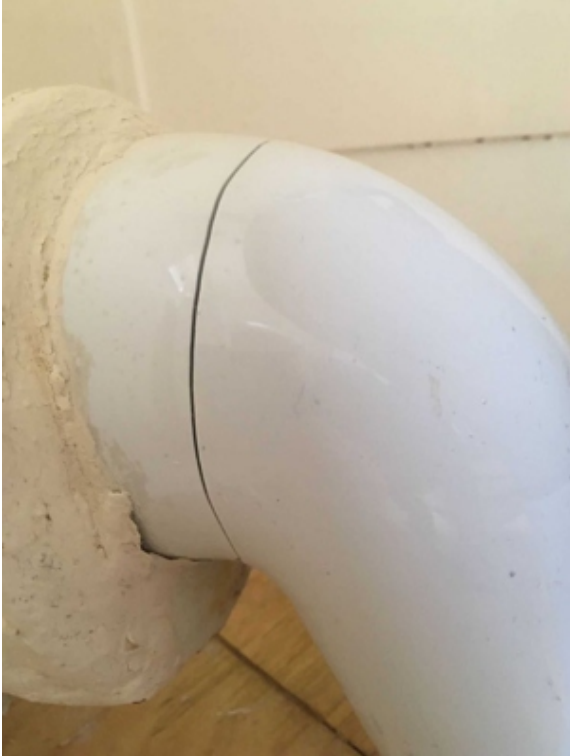
The hairline crack was around the entire diameter of the porcelain toilet soil pipe

The soil pipe connected the toilet with the sewer pipe behind. An unstable floor meant whenever the toilet was sat on, it tilted forward and pulled the pipe away from its connection to the back wall.

Eventually, the stress put on the pipe by this frequent movement caused a hairline crack to appear around the entire diameter.

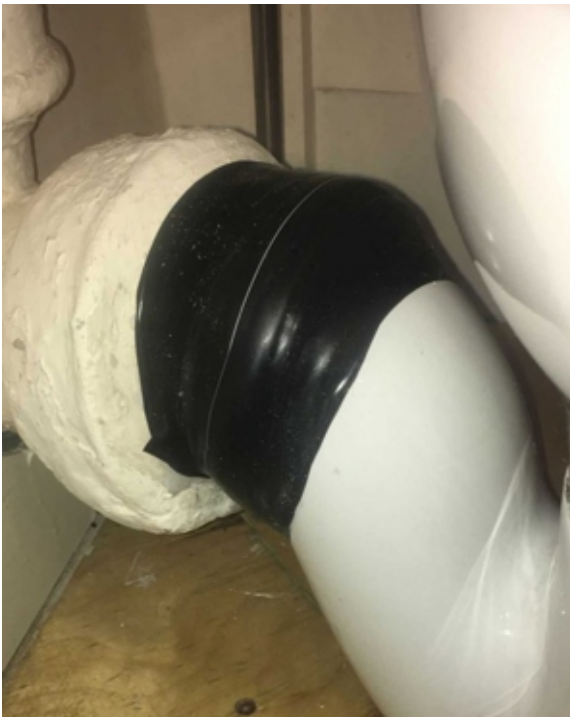
Wrap & Seal created a solid rubber ring, sealing the pipe whilst allowing it a degree of movement

One 50mm x 4m **Wrap & Seal Pipe Burst Tape** was applied around as much of the pipe as possible, fusing together to create a watertight rubber ring bonded to the porcelain.

This ring sealed the leak, allowed the pipe an element of movement to reduce stress, and prevented water escaping from any other cracks which developed elsewhere in the pipe.
