Liquid Metal Epoxy Repair Coating

Case Study

Portable Toilet Trailer Wastewater Tank Repair

Wastewater holding tanks underneath two luxury portable toilet trailers are repaired and strengthened after becoming weakened by external corrosion

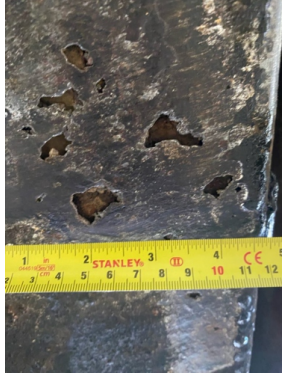
Wastewater holding tanks underneath the two trailers were suffering from corrosion and multiple holes

Two luxury portable toilet trailers were operated by a leading UK supplier. Corrosion had weakened the 3000 litre wastewater holding tanks underneath the units, causing multiple holes to appear.

With the plumbing, fixtures and fittings of both trailers otherwise in good working order and construction of new units extremely costly, the supplier wanted to seal the leaks and reinforce the tanks to avoid replacing the two trailers.

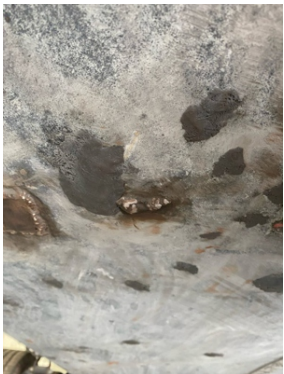
AB Original Black Epoxy Putty filled in all holes

Both trailers were repaired using the same method. The units were jacked up to access the tank and the metalwork ground to remove grime and rust.

Sylmasta AB Original Epoxy Putty in stick format repaired the holes. Enough putty was cut from the stick to fill a hole, kneaded by hand and pushed in. It hardened inside the hole for a permanent seal.

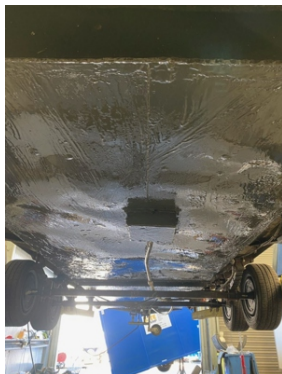
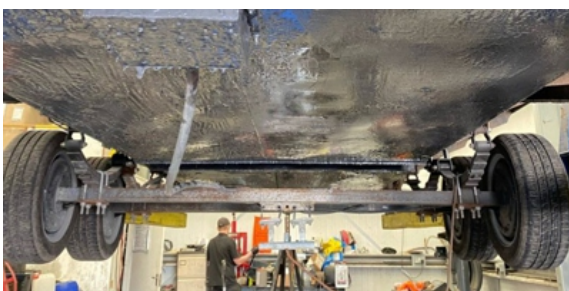
Liquid Metal was coated onto the underneath of the trailers to strengthen the brittle original metalwork and protect it from future corrosion

Once all holes had been filled, the entire 1.3 metres by 2.5 metres underneath of the unit was painted with **Liquid Metal Epoxy Coating** to create a new, smooth, hard-wearing, metallic surface.

This protected the tank from corrosion and encased it in an outer shell, capable of holding wastewater should the original metal be breached in future.
