Epoxy Putty Case Study

Gap Filling Between Toilet Waste Pipe & Floor

Sylmasta AB Original Epoxy Putty completes the plumbing in of a toilet waste pipe after a hole too big for the fitting was mistakenly cut into the bathroom floor

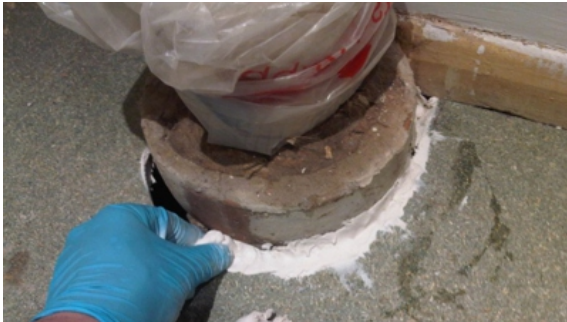
AB Original was kneaded by hand and then pushed into the crack, filling the gap

Once mixed, the putty was pushed into the gapping between the pipe and floor. As it was applied, it was smoothed off using a little water and a filling knife and then left to harden.

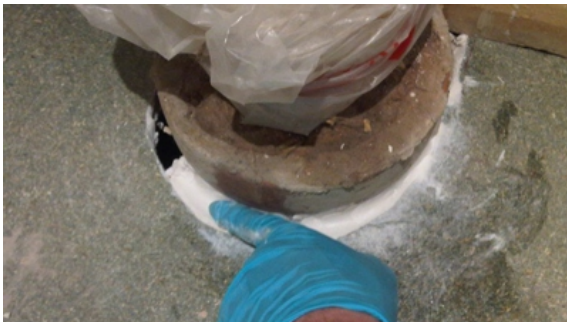
The putty was smoothed off using a little water and a filling knife as the application continued

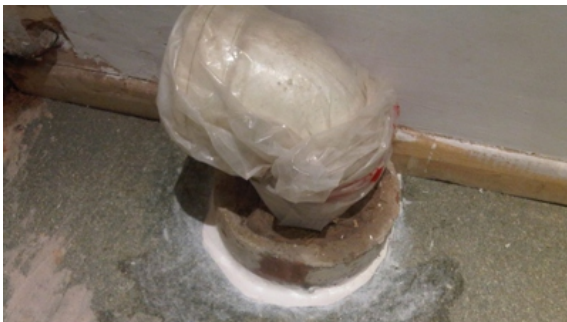
The completed repair with all gapping sealed and the waste pipe successfully plumbed in

A full cure was achieved in 24 hours, leaving the gapping permanently filled with a material sharing similar properties to the existing bathroom floor.
