# SYLWRAP Case Study

## Sugar Mill Alcohol Line Live Leak Pipe Repair

Having a SylWrap Contractor Case on site enabled a sugar mill in Costa Rica to make an instant repair when a pinhole leak developed in an alcohol line

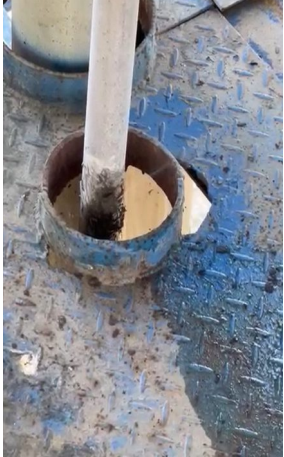
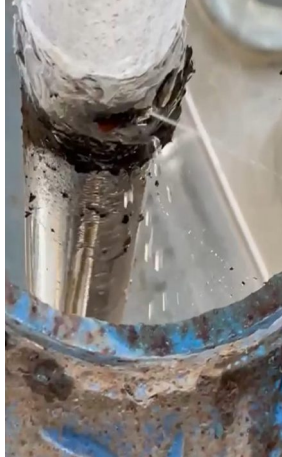
*Alcohol juice was spraying through a pinhole leak at a pointed where the line passed through a circular hole in the upper floor of a platform*

The pipeline was 70mm in diameter and ran vertically up a tower. It carried alcohol juice extracted from sugar cane during fermentation, which would be used in the production of spirits such as rum and guaro.

A pinhole leak developed in a weakened section where the line passed through a circular hole in an upper floor of the platform. Alcohol juice was left spraying out at around two bar pressure.

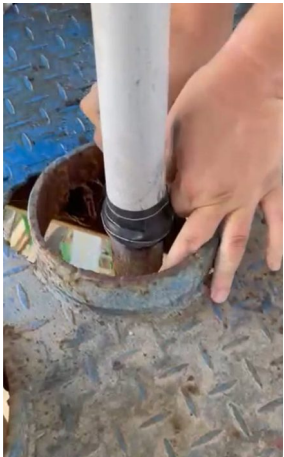
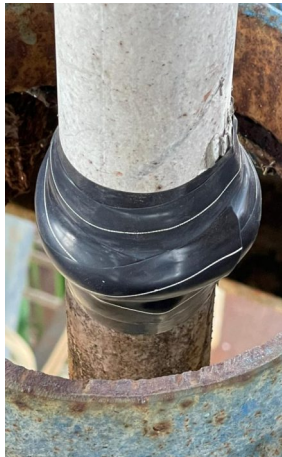
*Wrap & Seal Pipe Burst Tape sealed the live leak despite the space constraints around the pipe*

The line could not be isolated, so **Wrap & Seal Pipe Burst Tape** was used to seal the leak. Despite the space constraints around the pipe, the Tape was stretched and amalgamated successfully.

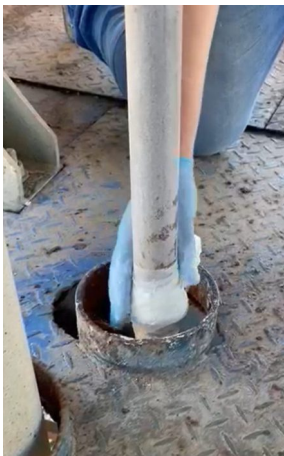
*The repair was reinforced and protected with SylWrap HD Pipe Repair Bandage*

Once the engineer making the repair was satisfied the leak was sealed, a **SylWrap HD Pipe Repair Bandage** was applied for reinforcement.
