# SYLWRAP Case Study

## Hospital Repair Cracked Cast Iron Downpipe

A 1.05-metre long crack in an internal cast iron downpipe leaking rainwater into a hospital ward is sealed in 30 minutes with no disruption to patients and staff

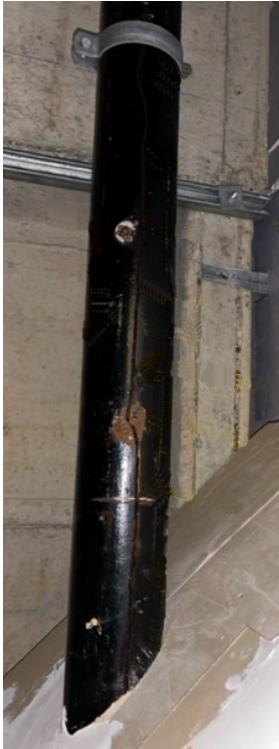
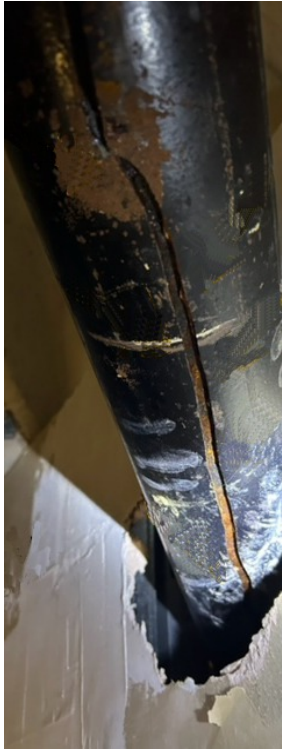
*Water escaping through the 1.05-metre long crack in the downpipe had saturated surrounding plasterboard and was now leaking into a nearby hospital ward*

The hospital had an ageing 150mm diameter cast iron pipe system taking rainwater away through the building. A leak into a ward alerted staff to a problem in a wall cavity containing a section of downpipe.

A drainage engineer accessed the cavity and pipe, discovering a 1.05-metre crack. Budget restraints and the possibility of new facilities being built meant replacing the damaged pipework was not viable.

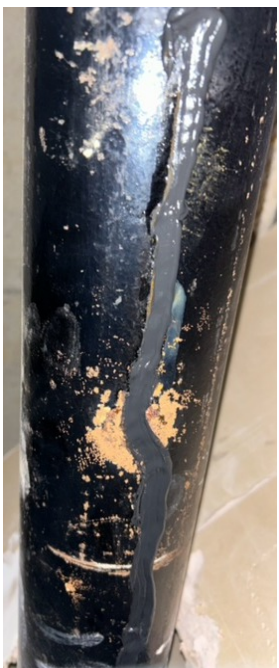
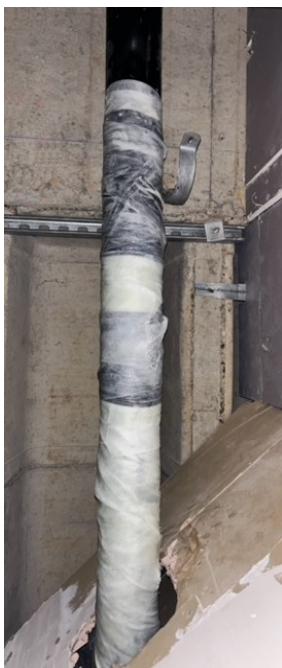
*The crack was sealed by extruding CrackSeal directly into it. The entire length of pipe was then reinforced with SylWrap for a permanent repair*

**CrackSeal Sealant** was extruded directly into the crack until it was totally filled. It hardened almost instantly to seal the crack, after which it was left for 10 minutes to form a skin.

Two **SylWrap Pipe Repair Bandages** were then wrapped along the length of the crack SylWrap set rock-hard within minutes, forming an impact resistant sleeve protecting both the CrackSeal repair and pipe.
