SYLWRAP Case Study

600mm Concrete Water Main Pipe Break Repair

A city authority in Canada reduce a significant 2 bar leak down to a slow drip by repairing a break in an underground 600mm concrete water main pipe

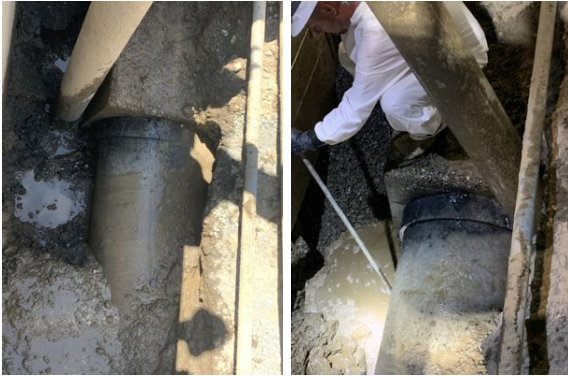
The break was somewhere beneath the joint in the pipe at the point it passed into the concrete wall

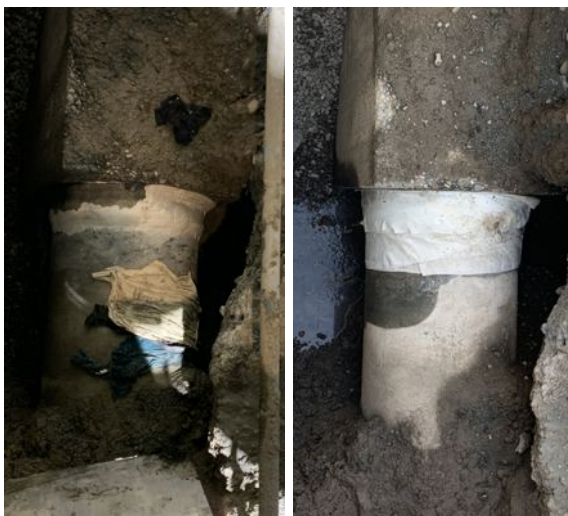
Once water loss had been reduced to an acceptable level by encompassing the leak area, the repair was reinforced with SylWrap Bandage

Once water loss had been reduced to a slow drip, the putty was overwrapped with 2 x SYL866HD **SylWrap Pipe Repair Bandage**. SylWrap formed a rock-hard outer shell, increasing the effectiveness of the repair
