SYLWRAP Case Study

Water Treatment Plant 6 Bar Live Leak Repair

A water company in Malaysia make their first repair with a SylWrap Contractor Case, sealing a 6 bar live leak on a 300mm steel pipe at a treatment plant

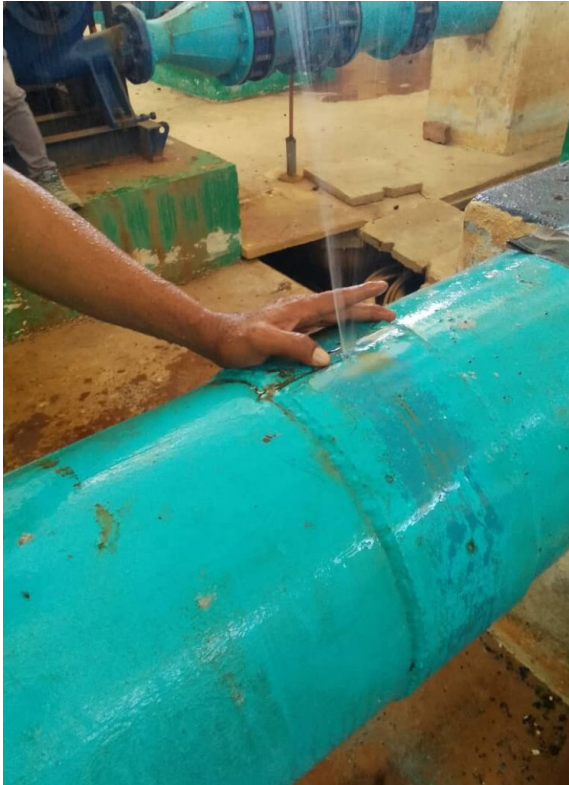
Water had been escaping the 300mm steel pipe for two weeks through a 4mm hole at 6 bar pressure

The pipe had been leaking for two weeks through a 4mm hole. It could not be shutdown because of its importance to operations at the plant, leaving a steady jet of water escaping and saturating the floor.

Such a leak would normally be sealed by the water company using a clamp. The hole though was located in a welded saddle joint sitting 15mm above the original pipe, making a clamp ineffective.

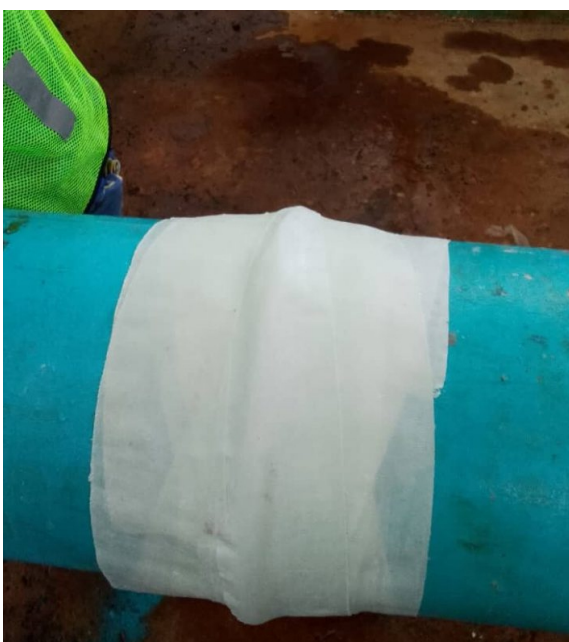
Three 50mm x 11m Wrap & Seals built a repair with enough resistance to withstand 6 bar pressure, followed by reinforcement with SylWrap Bandage

Three 50mm x 11m Wrap & Seal were applied over the pinhole until water was no longer seeping through. This indicated the tapes had amalgamated together, building enough pressure resistance to hold 6 bar.

The repair was reinforced with a SYL866HD **SylWrap Pipe Repair Bandage** which formed a rock-hard, impact resistant shell protecting the Wrap & Seal.
