SYLWRAP Case Study

Nursing Home Heating Pipe Live Leak Repair

A UK nursing home avoids having to shut down its heating system in winter by making a live leak repair to a 150mm metal pipe flooding a loft space

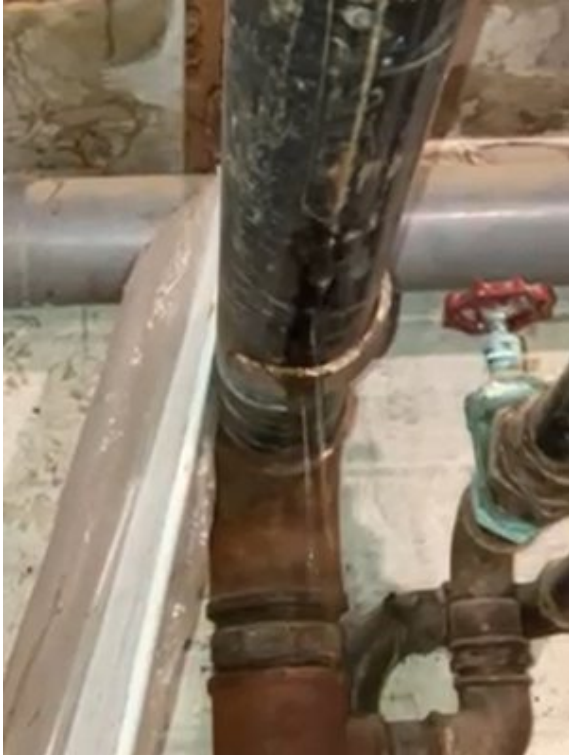
The heating pipe was losing water through a pinhole leak, saturating surrounding loft space

A constant, steady drip of water was escaping the 150mm metal pipe through a pinhole and saturating the surrounding loft space.

Wrap & Seal Pipe Burst Tape was applied over the pinhole leak. It fused to form a solid rubber band around the pipe, easily withstanding the pressure the heating pipe operated at. This contained the leak.

A **SylWrap HD Pipe Repair Bandage** was then wrapped and smoothed over the leak area. Within minutes, it cured to form a rock-hard, impact resistant shell which protected and reinforced the repair.

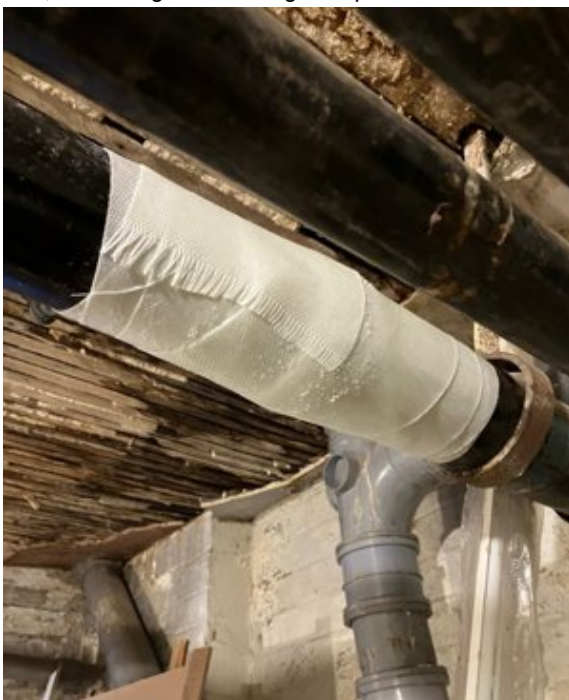
Wrap & Seal sealed the leak before overwrapping with SylWrap HD Bandage for a permanent repair
