# Liquid Metal Epoxy Repair Coating

# Case Study

## Leaking Worthington Simpson Pump Repair

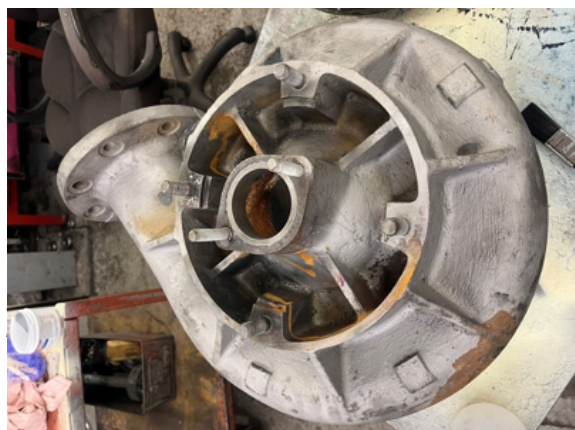
Heavy corrosion was removed from the inside pump head by the pump repair company via shot-blasting

A specialist pump repair company were asked by a client to refurbish a heavily corroded Worthington Simpson pump head. They disassembled and shot-blasted the inside to remove all rust, dirt and grime.

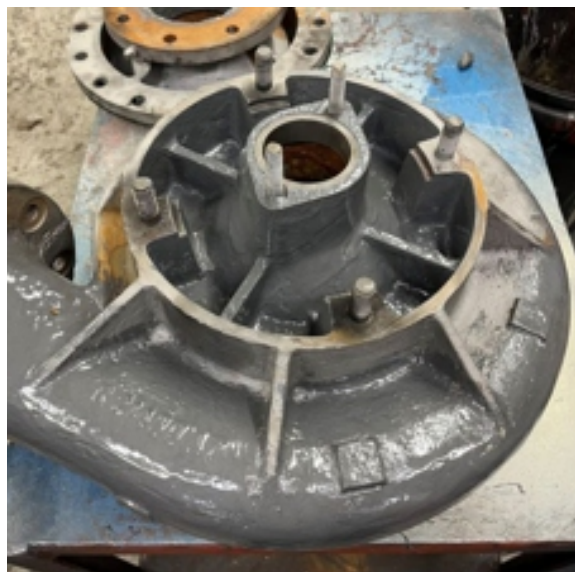
Once shot-blasting was completed and the pump pressure tested, multiple pinhole leaks were found

When the pump was tested after repair, it was found to be leaking. Shot-blasting had created pinholes in the casing, through which water could spray out.

Superfast Steel sealed the pinholes in the casing and a 3mm coating of Liquid Metal provided thorough protection against future corrosion

After an attempt to patch weld a pinhole failed, the company used **Superfast Steel Epoxy Putty** to seal the leaks. Small amounts of putty were mixed and pressed flat onto the casing, covering every pinhole.

Superfast Steel hardened within 10 minutes. **Liquid Metal Epoxy Coating** was then used to seal the casing. Three coatings were applied, forming a metallic layer 3mm thick covering the pump interior.
