# SYLWRAP Case Study

## Lead Pipe Leaking Inside House Wall Repair

A homeowner in the United Kingdom accesses and makes a DIY repair to a vertical 25mm diameter lead water pipe leaking inside the wall of their house

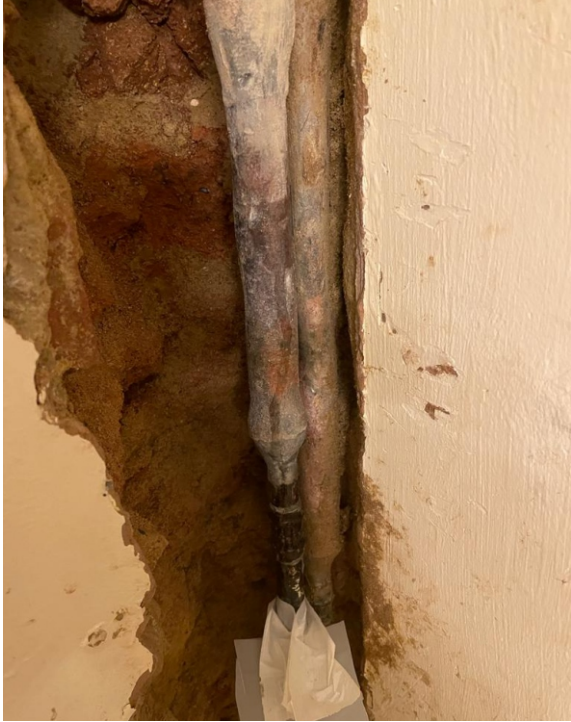
After cutting away the drywall, the homeowner found a leaking vertical 25mm lead water pipe

Discolouration appeared on a white wall close to a window during winter. The homeowner initially put it down to condensation and damp from the window.

But when summer arrived and the wall remained wet, they suspected a leak. The drywall was removed to access the cavity, where they found a 25mm lead pipe running vertically which was weeping water.

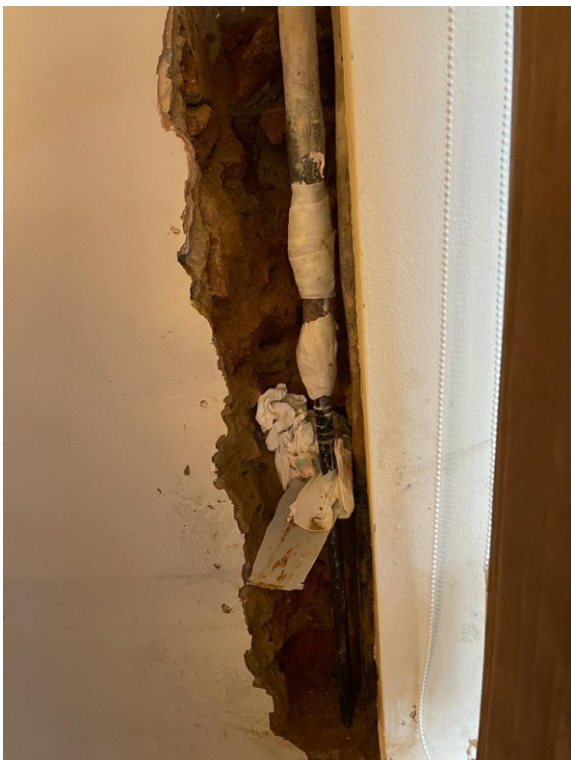
Despite the space constraints in the wall, the pipe was repaired using Wrap & Seal and SylWrap HD

**Wrap & Seal Pipe Burst Tape** was instead used because it bonds to itself more than the substrate.

Despite the space constraints, the tape could still be stretched by three times its length as it was wrapped. This enabled it to form a solid rubber band, exerting pressure over the leak to contain pipe content.

The repair was then overwrapped with **SylWrap HD Pipe Repair Bandage**, which provided a rock-hard, impact resistant protective sleeve around the pipe.

Completing the repair took under 20 minutes. Water supply to the house was turned back on afterwards and the pipe inspected regularly for the next two days.

With no signs of any leakage and the pipe remaining bone dry, the repair had been a success.
