SYLWRAP Case Study

Plastic Pipe Joint Solvent Cement Failure Repair

A homeowner in the United Kingdom repairs a plastic pipe joint leaking water through a failed solvent cement bond in the confined loft space of their house

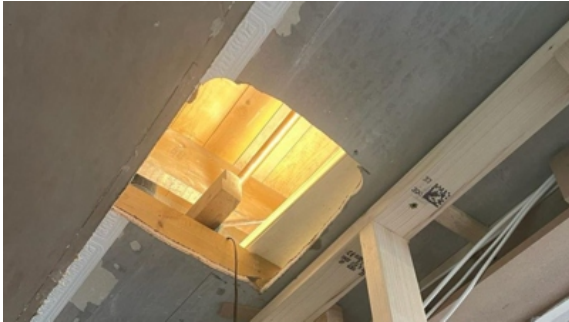
The joint had to be sealed with the pipe in place due to limited access through a small hole in the ceiling

The plastic pipe was located in a confined loft space in the roof of the house which could only be reached through a small hole in the ceiling.

Cutting out and replacing the leaking section was not an option because of the lack of access into the loft. The joint needed to be sealed with the pipe in place.

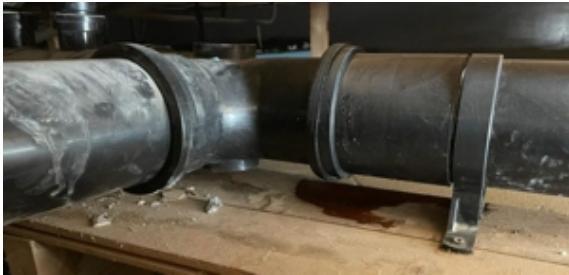
Water was escaping through failed solvent cement and saturating the wooden floor underneath the joint

Solvent cement bonding two sections of pipe together had weakened and failed, allowing water to escape and saturate the surrounding wooden floor.

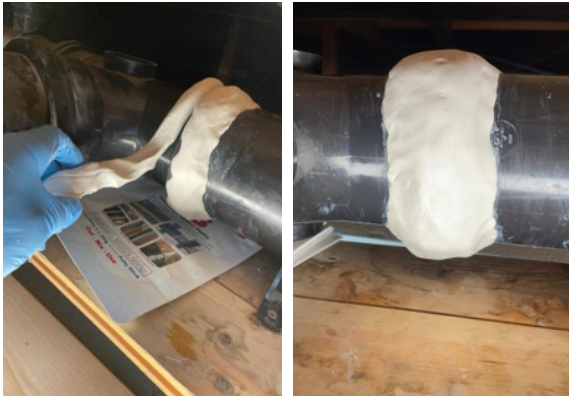
AB Original was formed into three long 'sausages' which were wrapped and smoothed around the joint, leaving it completely covered in a ring of epoxy putty

Sylmasta AB Original Epoxy Putty was used to encompass the leaking joint around its entire diameter with a watertight material.

AB Original was mixed by hand, formed into a long 'sausage shape' and wrapped around the joint. The putty was pressed down firmly and smoothed against the pipe with a little water.

Three AB Original 'sausages' were used to completely cover the joint, leaving it surrounded by a ring of putty.

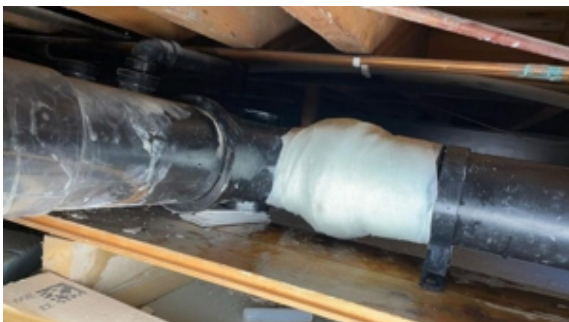
The repair was completed by reinforcing the leaking section with SylWrap HD

SylWrap HD Pipe Repair Bandage was then wrapped over the top whilst the putty remained slightly tacky and soft. It forced AB Original as tightly as possible against the joint for a more effective seal.

Once AB Original and SylWrap HD cured, the leaking joint was fully encompassed with no sign of any water escaping.
