SYLWRAP Case Study

Corroded Porth Pipe Bridge Refurbishment

Dwr Cymru Welsh Water use the Sylmasta Pipe Refurbishment System to save nearly £200,000 by repairing rather than replacing a dilapidated pipe bridge

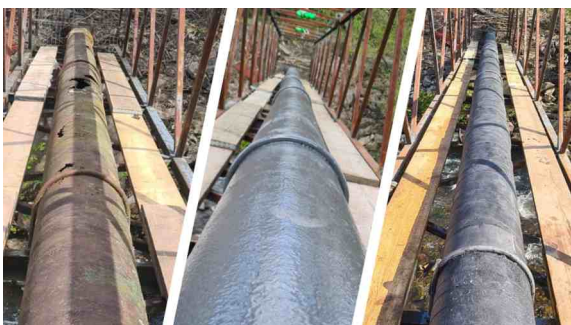
The repair cost £12,000 in total and took three days to complete. It left a smart-looking, fully refurbished pipe bridge protected from future corrosion and breaches.
