Wrap & Seal PIPE BURST TAPE Case Study

Water Main Pipe Leaking Expansion Joint Repair

A water company in the UK repair a leaking aluminium expansion joint fitted to a 225mm steel water supply pipe running over a major road suspension bridge

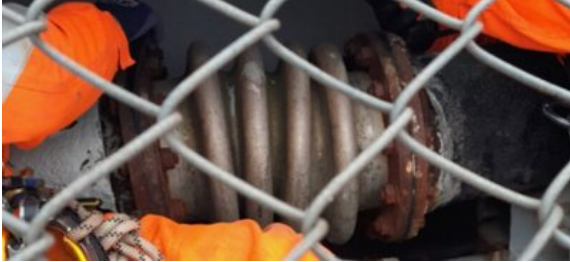
The expansion joint was leaking through a split between the two bent bellows on the right hand side

The aluminium expansion joint was fitted to reduce stress on the pipe caused by movement of the bridge. A split appeared in the expansion joint between two bellows, through which water was leaking.

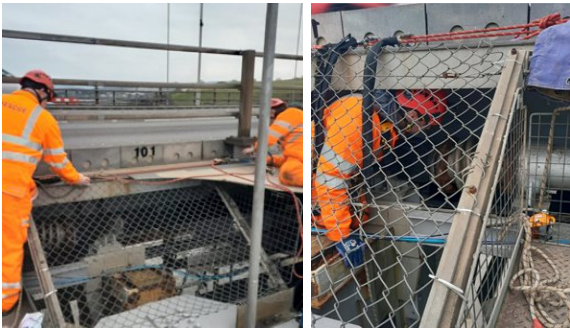
The steel pipe ran beneath the suspension bridge road deck in a severely cramped space, making access for repair difficult

The 335-metre suspension bridge provided an important link between two counties. It carried an A road over a river with the water main fixed directly beneath the road deck in a very constrained space.

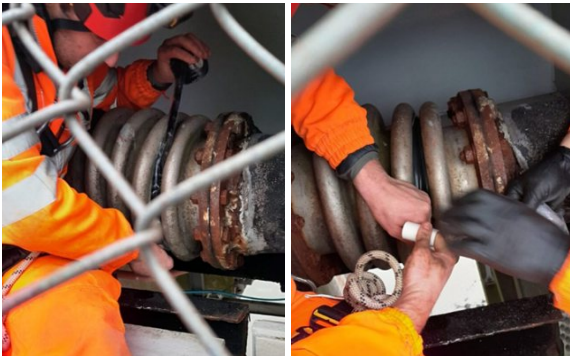
Wrap & Seal was applied between the bellows, covering the split in the expansion joint

On the day of the repair, the expansion joint had contracted to the point of failure. But even with the reduced space between the bellows, the engineers were able to apply **Wrap & Seal Pipe Burst Tape**.

Three PB-50x4m tapes were used. The tapes amalgamated together to form a solid rubber band over the leak, filling the gap between the two bellows.

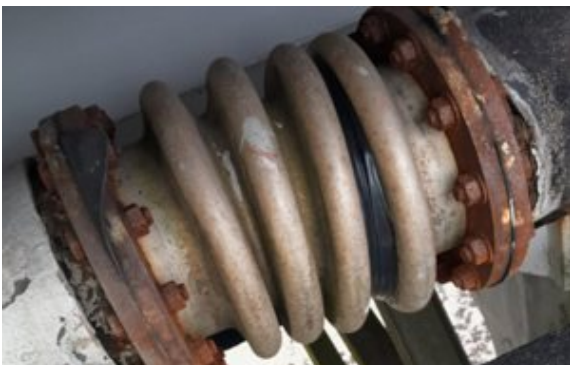
The completed repair left a solid rubber band over the leak, containing pipe content
